REPORT

Quinquennial Structural Stability Assessment and Annual Engineering Inspection, Ponds M5 and M7, Reid Gardner Generating Station

PREPARED FOR: File
PREPARED BY: NV Energy, Jacobs
DATE: June 28, 2021

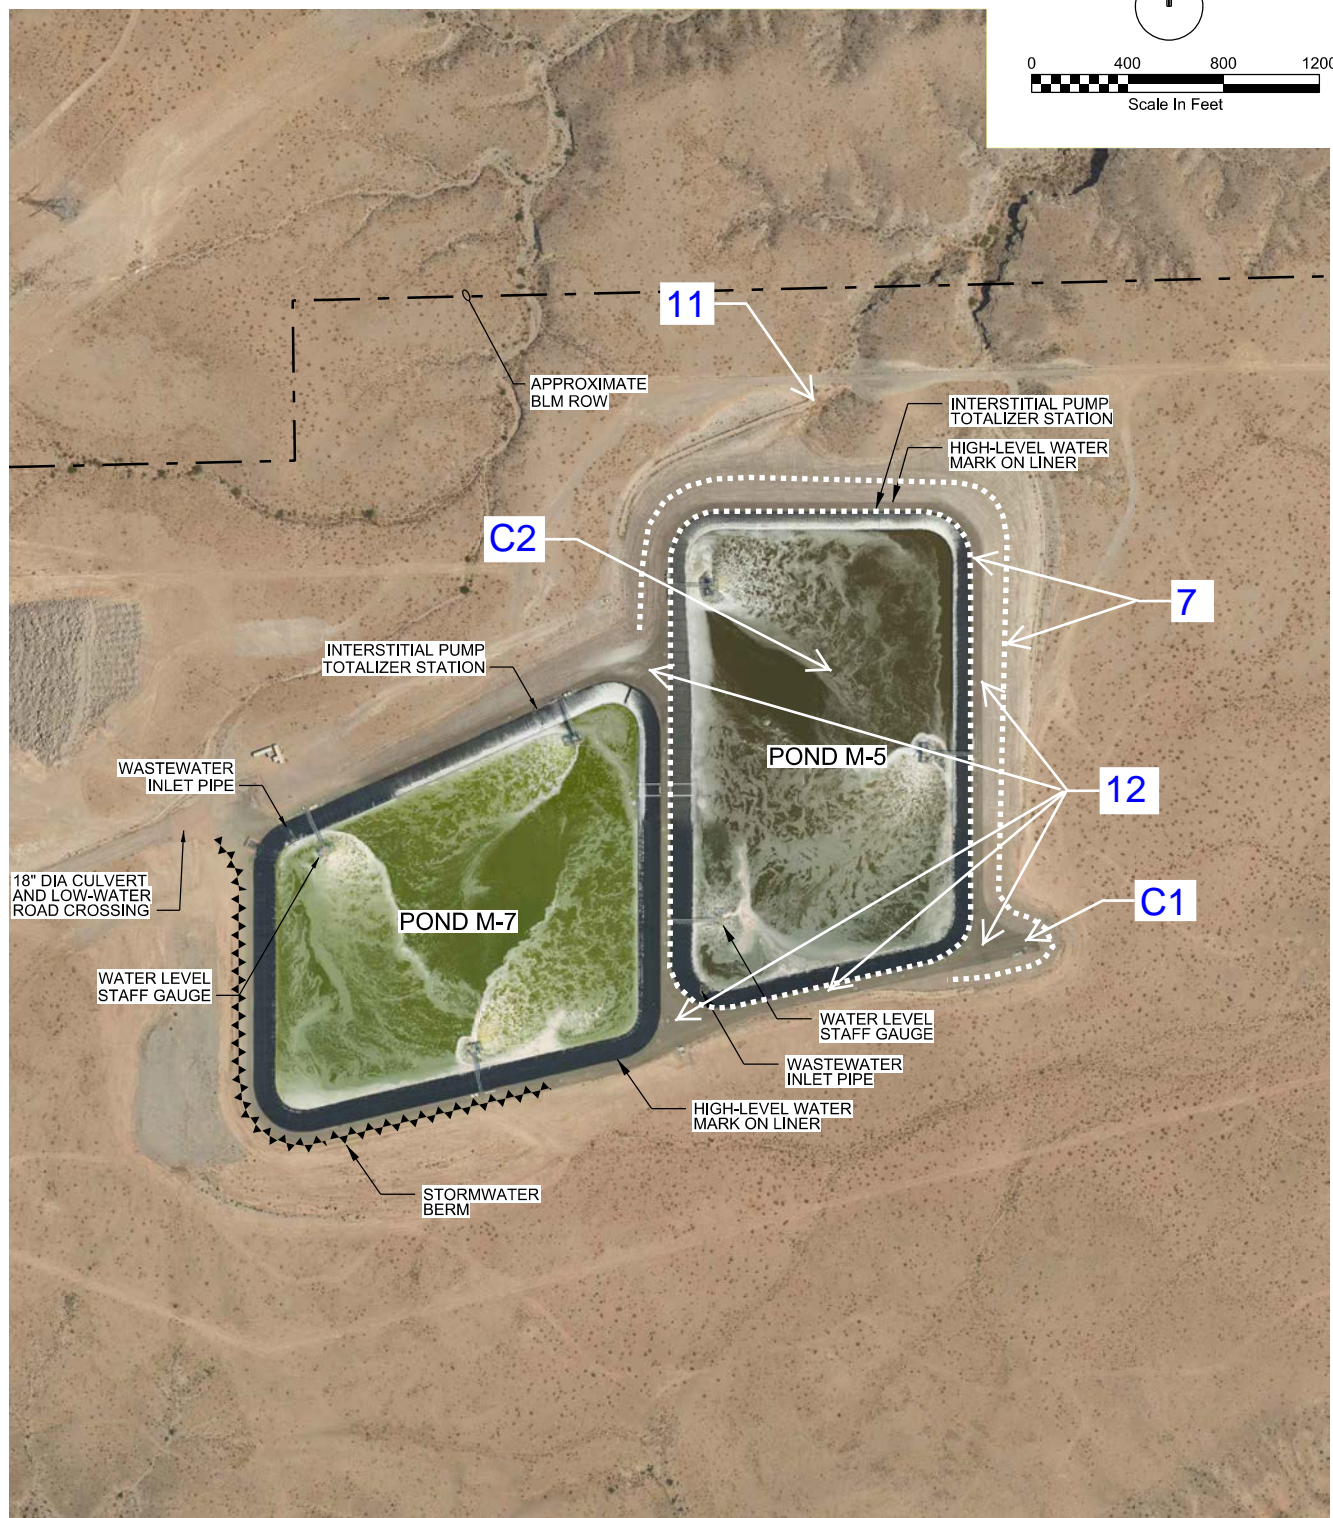
POND M5 CCR IMPOUNDMENT INSPECTION FIGURE

7. Small annual weeds are growing sparsely along the embankment edge and in the joint between liner and asphalt. Generally, up to 12 inches high and spaced every few feet to few inches.

11. Lower reach of riprap ditch is partially covered at extreme lower end. No apparent change from previous annual inspection.
12. Small pieces of asphalt have broken away from road on the east side (previously noted). Age cracking of the asphalt pavement is present in many locations, especially at construction joints. There are no vertical offsets or other evidence of failure of the earth structure.

20. The pond has been removed from service and is completely isolated from the influent system feeding the impoundment.
- C1. Stubbed-out and blind-flanged end HDPE pipe near the southeast corner of Pond M5 has been gouged. The pipe has never been used and is hydraulically isolated. No change from previous annual inspection.

- C2. Solids are evident over the entire pond, few areas of open water, no impact.

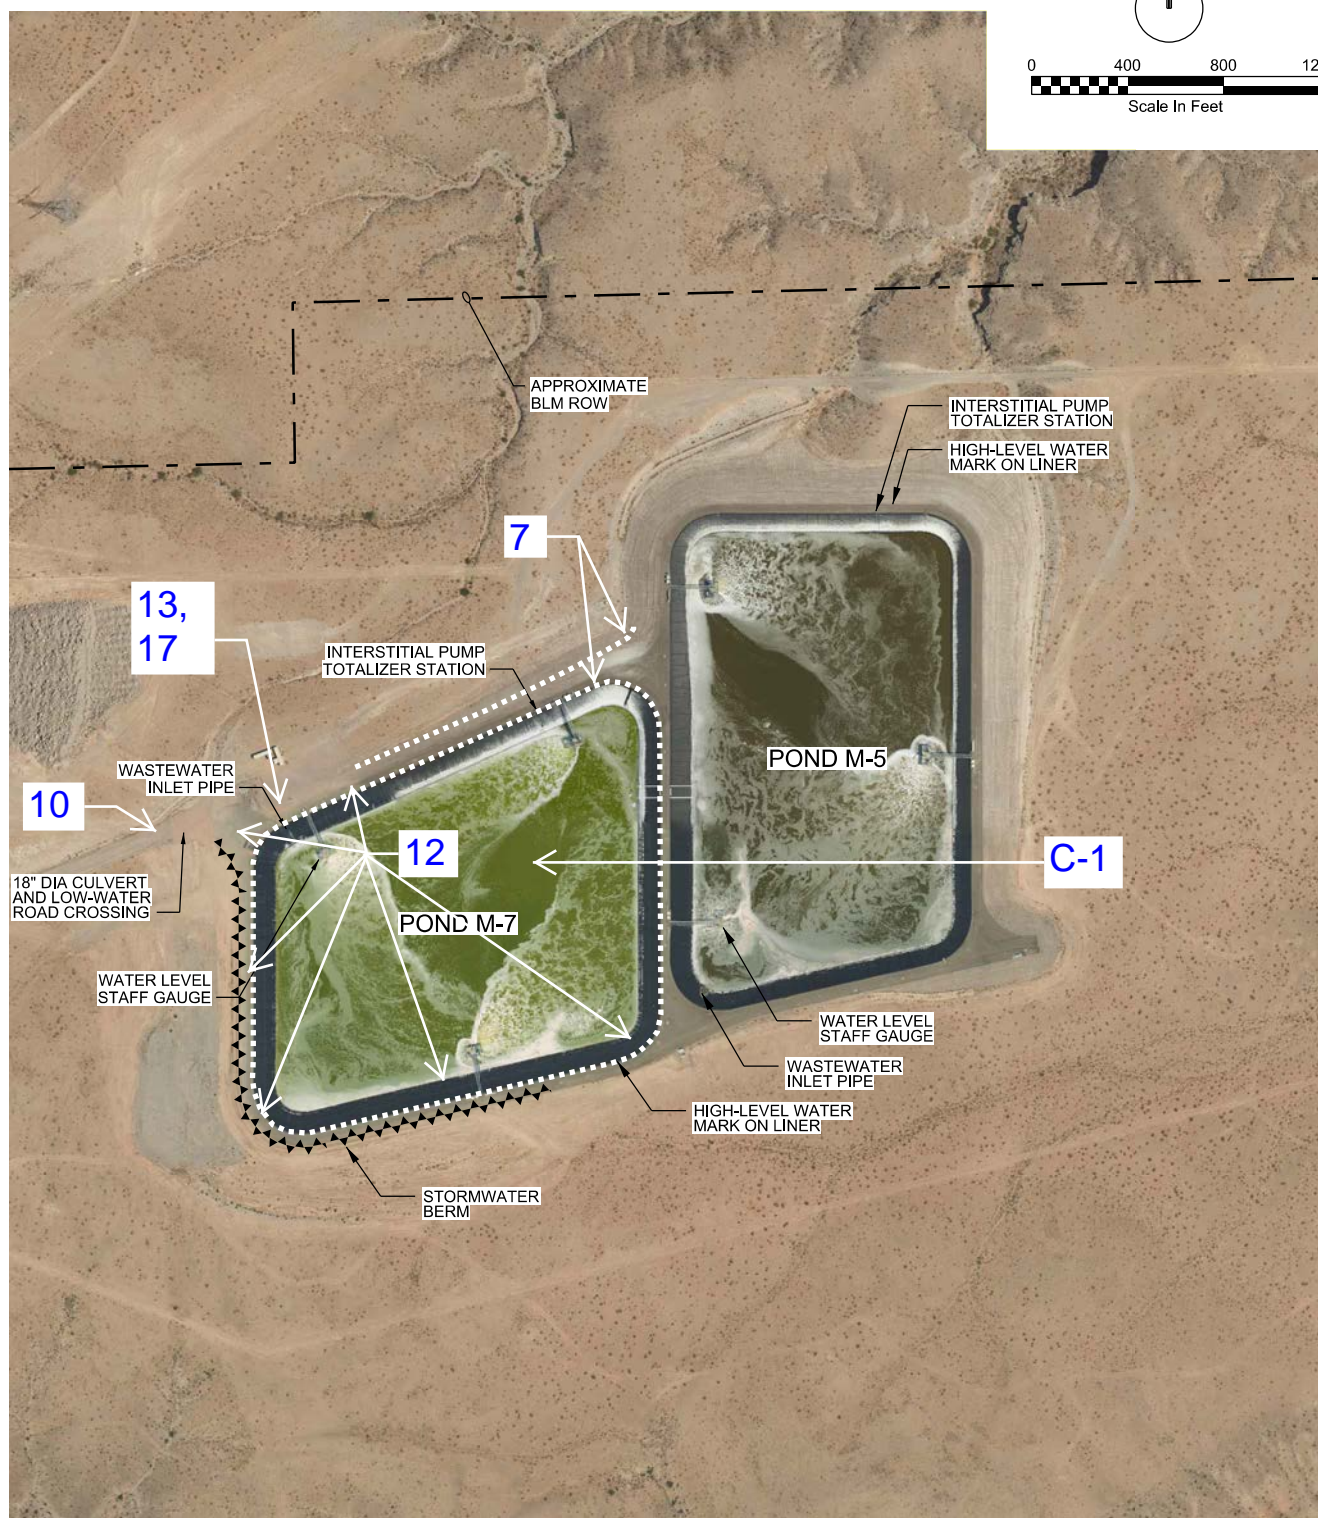
CCR IMPOUNDMENT INSPECTION FIGURE

7. Small annual weeds are growing sparsely along the embankment edge and in the joint between liner and asphalt. Generally, up to 12 inches high and spaced every few feet to few inches.

10. Small number of tumbleweeds are present at both inlet and outlet of the culvert, otherwise the culvert is clear.
12. Age cracking of the asphalt pavement is present in many locations, especially at construction joints. There are no vertical offsets or other evidence of failure of the earth structure. No significant change from previous annual inspection.

13. Small portion of the anchor trench along the northwest corner of pond near the aeration equipment has settled, no apparent change from previous annual inspection.

17. The lined surface over the down slope trenches for the two cleanout pipes in the NW corner appear to have settled 2-3 inches. No sign of liner tension or movement. No apparent change from previous annual report.

21. The pond has been removed from service and is completely isolated from the influent system feeding the impoundment.
- C1. Solids are present over the entire impoundment, only small areas of open water showing, no impact.
