REPORT

Quinquennial Structural Stability Assessment and Annual Engineering Inspection, Ponds M5 and M7, Reid Gardner Generating Station

PREPARED FOR: File
PREPARED BY: NV Energy, Jacobs
DATE: June 28, 2021

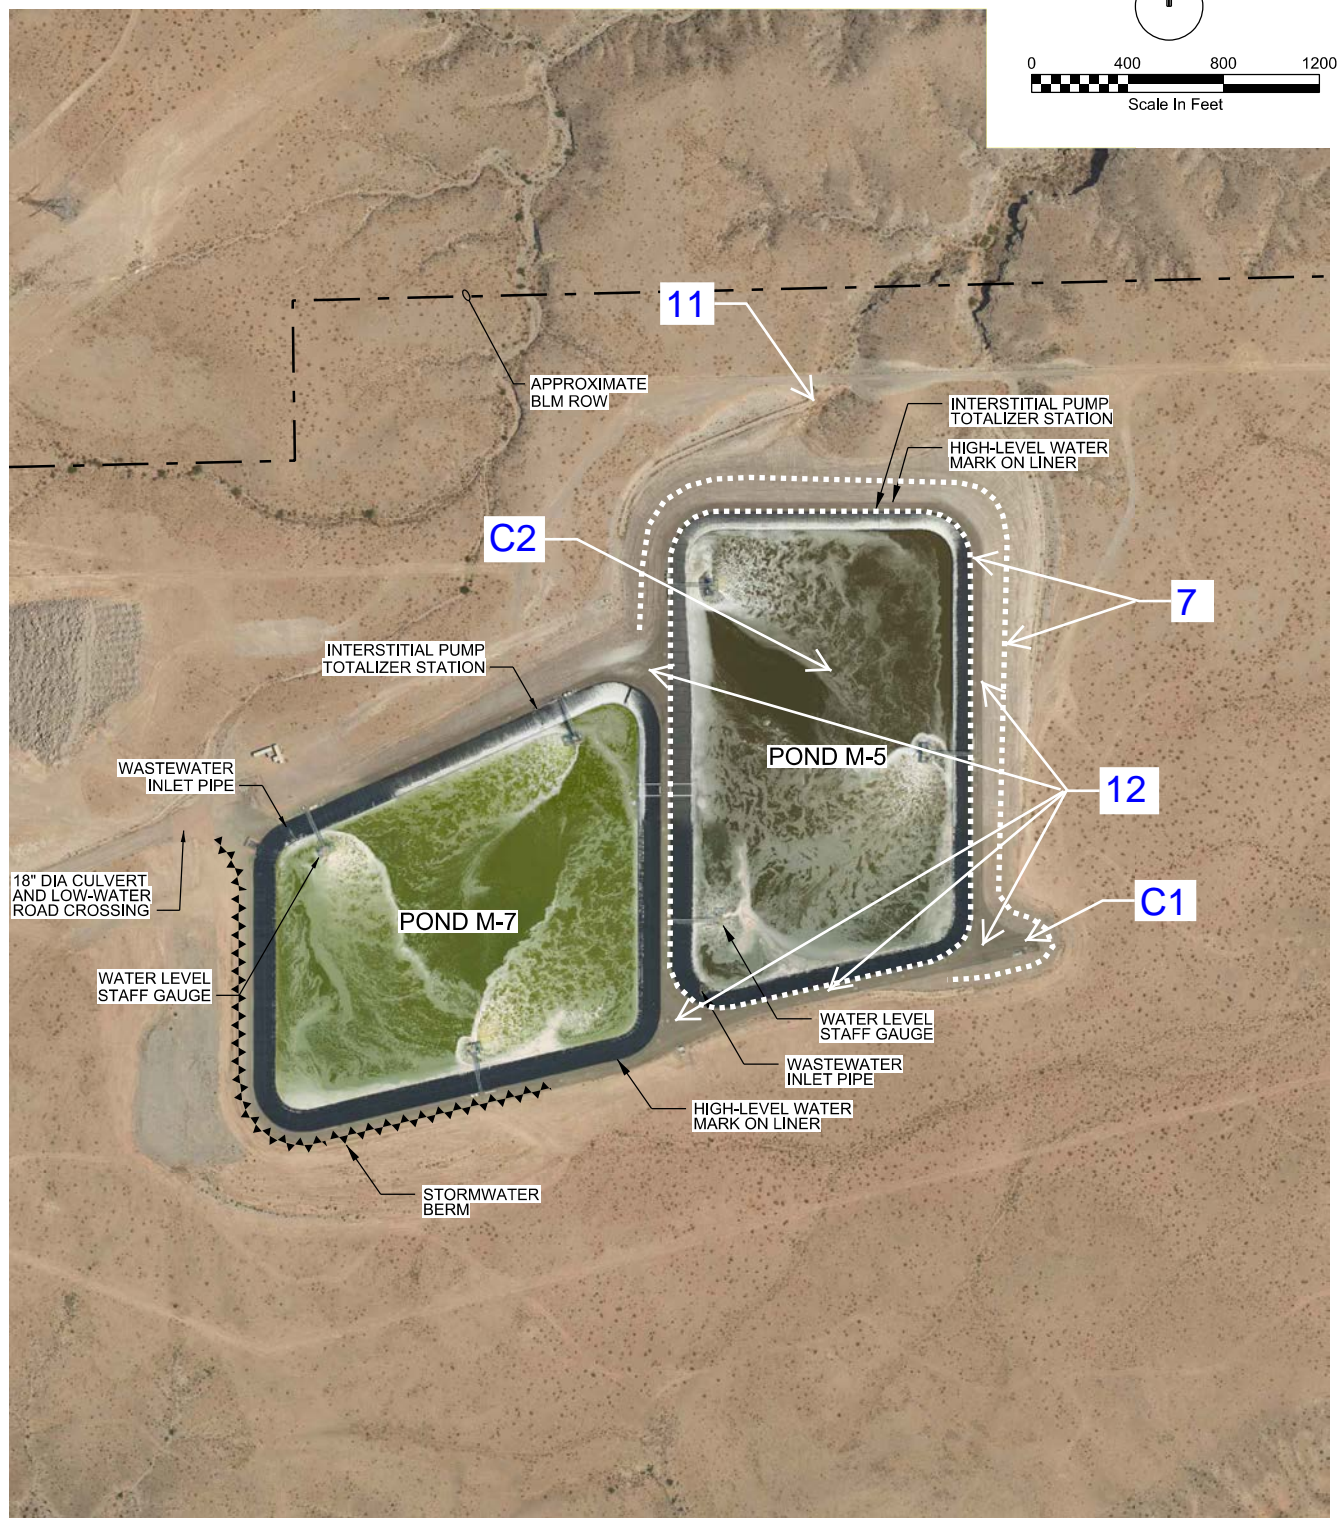
11. Lower reach of riprap ditch is partially covered at extreme lower end. No apparent change from previous annual inspection.
12. Small pieces of asphalt have broken away from road on the east side (previously noted). Age cracking of the asphalt pavement is present in many locations, especially at construction joints. There are no vertical offsets or other evidence of failure of the earth structure.

- C2. Solids are evident over the entire pond, few areas of open water, no impact.

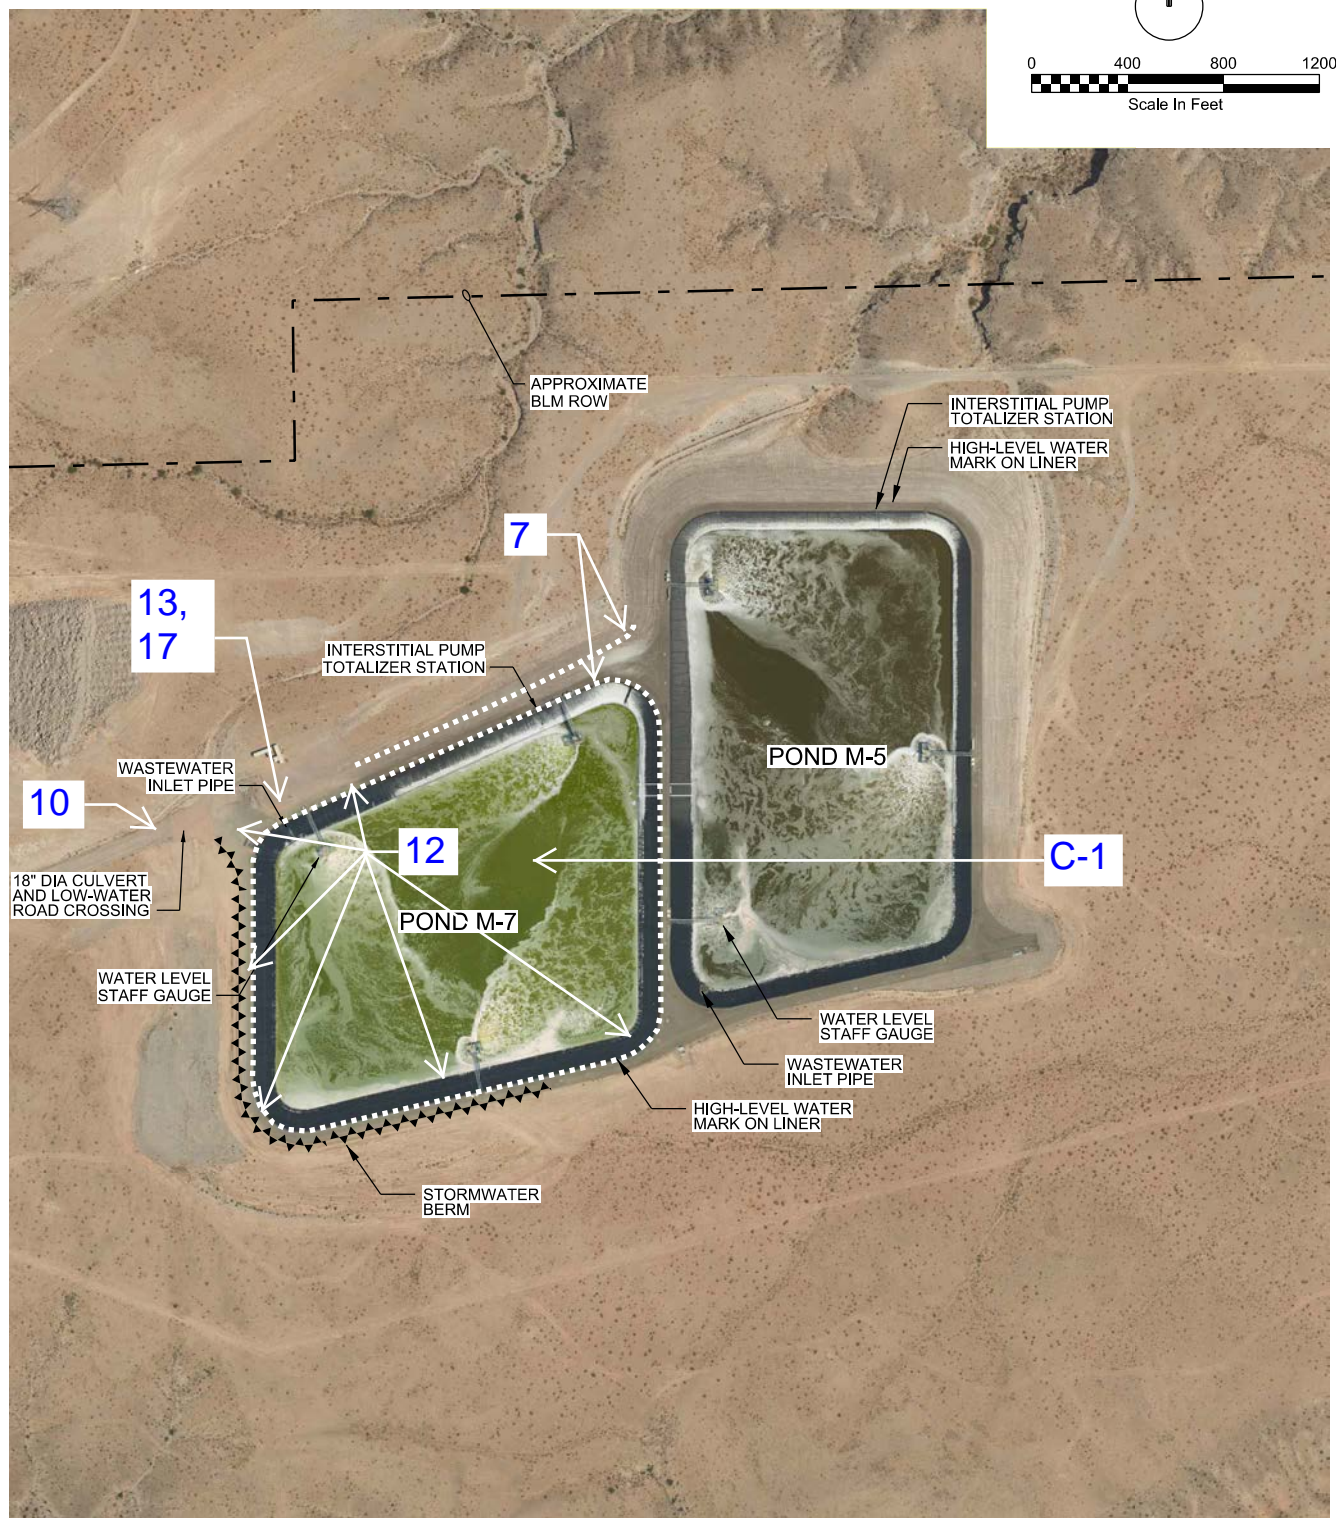
10. Small number of tumbleweeds are present at both inlet and outlet of the culvert, otherwise the culvert is clear.
12. Age cracking of the asphalt pavement is present in many locations, especially at construction joints. There are no vertical offsets or other evidence of failure of the earth structure. No significant change from previous annual inspection.

21. The pond has been removed from service and is completely isolated from the influent system feeding the impoundment.
- C1. Solids are present over the entire impoundment, only small areas of open water showing, no impact.
