TECHNICAL MEMORANDUM

Initial Structural Stability Assessment, Ponds M5 and M7, Reid Gardner Generating Station

PREPARED FOR:	NV Energy
PREPARED BY:	Nathan Betts, PE/CH2M
REVIEWED BY:	Dean Harris/CH2M
DATE:	October 12, 2016
CH2M PROJECT NO.:	671059.01.02

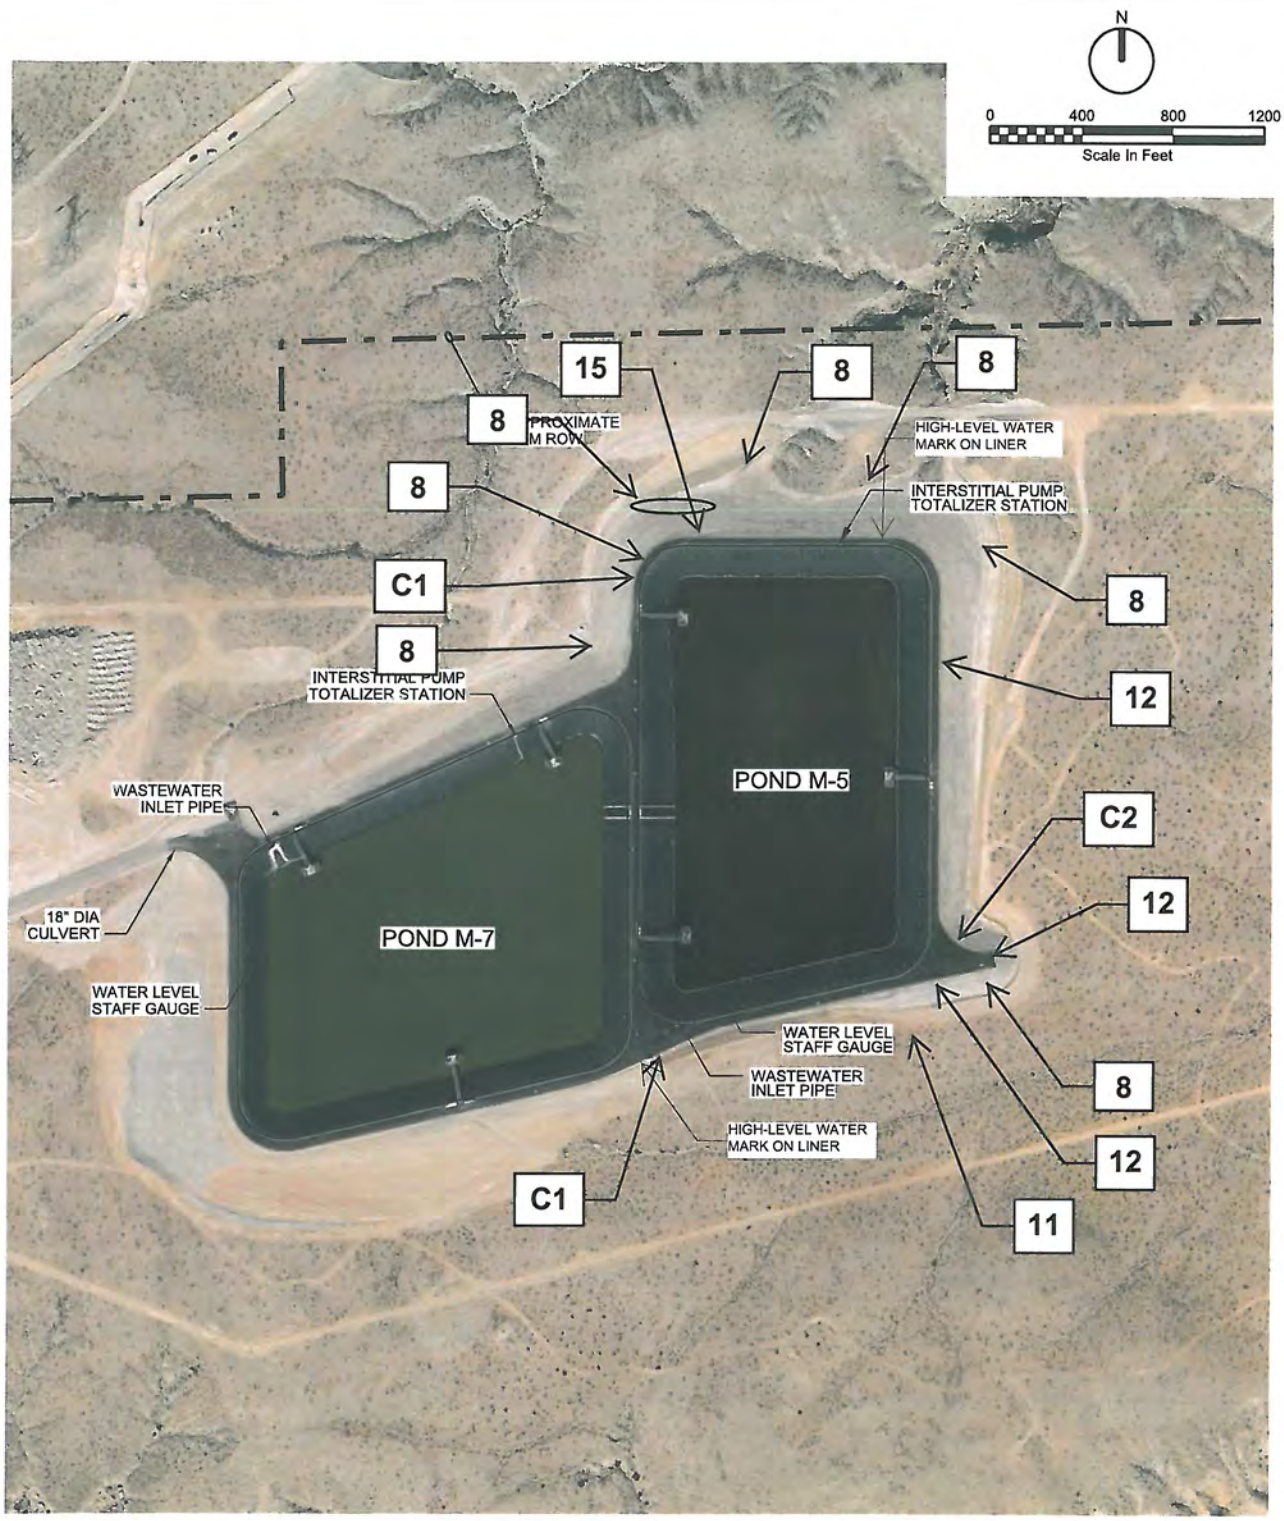
CCR IMPOUNDMENT INSPECTION FIGURE

8. Runnels are present on north side of pond, especially at the concave corner formed by northern intersection of Pond M5 and Pond M7. Runnels on M5 are generally less than 6 inches deep and spaced at 15-30 yard intervals. Runnels occasionally extend the full length of slope and have broken through some small bumps/windrows that appear to have been created by equipment tracks. See figure for areas with most significant runnels.

11. Lower reach of riprap ditch is starting to fill with sediment. Riprap on bottom of channel is becoming less visible.

12. 10-foot long x 1/8-inch wide crack in asphalt concrete pavement (ACP) at SE corner. <12-inch piece of asphalt has broken away from road on the east side (no change from previous annual inspection). ACP being undermined on SE corner. /// 15. Two delineators around the settlement monument near northwest corner of Pond M5 are broken, one is lying on the ground. /// 20. Bottom half of pipe is filled with Glauber's salt. /// C1. There is no cap/cover on the riser pipes, used to clean out the interstitial leak detection and collection system, near the northwest and southwest corners of Pond M5. /// C2. The stubbed-out and blind-flanged end of the partially completed underground HDPE pipe near the southeast corner of Pond M5 has been gouged and the associated detection wire is broken. The pipe has never been used and is hydraulically isolated (no change from previous annual inspection). -----END OF FORM----------

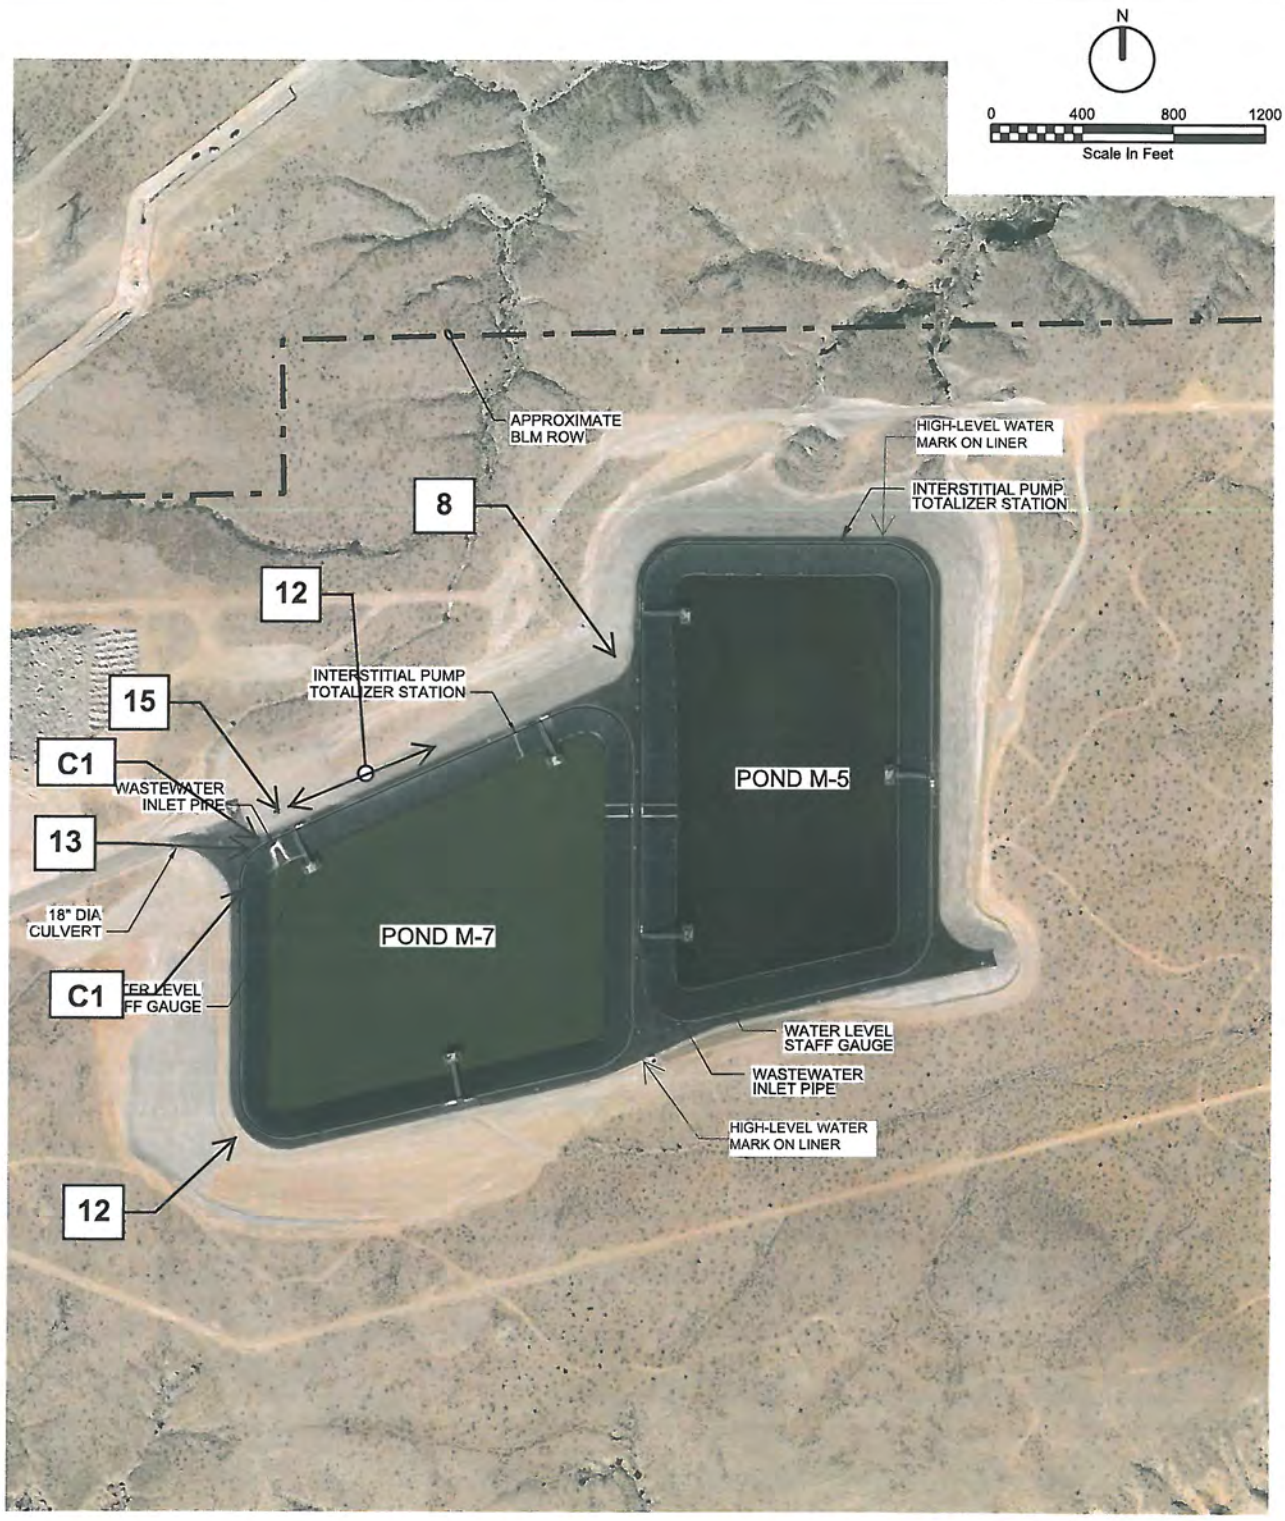
CCR IMPOUNDMENT INSPECTION FIGURE

8. Runnels are present on north side of pond, especially at the concave corner formed by northern intersection of Pond M5 and Pond M7. Runnels on M7 are generally less than 6 inches deep and spaced at 15-30 yard intervals. Runnels occasionally extend the full length of slope and have broken through some small bumps/windrows that appear to have been created by equipment tracks. See figure for areas with most significant runnels.

12. Along a portion of the north berm there are transverse and longitudinal cracks along the inboard edge of pavement and it appears that the cracks were formed by asphalt pavement being pushed upward. No change from previous annual inspection. At the southwest corner of pond, where the slope is incised, there are also approximately 8-10 longitudinal cracks forming on the outboard edge to the centerline of the pavement; otherwise no change from previous annual inspection.

13. The anchor trench along the northwest corner of M7 has settled, no change from previous annual inspection.

15. A delineator around the settlement monument near northwest corner of Pond M7 is broken and lying of the ground.

21. Bottom half of pipe is filled with Glauber's salt, but liquid is flowing through the pipe and into the pond without restriction.

C1. There is no cap/cover on two riser pipes, used to clean out the interstitial leak detection and collection system, near the northwest corner of Pond M7.----------END OF FORM----------
