# Emergency Action Plan: Reid Gardner Station, Mesa Ponds M5 and M7

Revision 04

February 2025

Pond Name	National Inventory of Dam Number	Nevada State Identification Number
Mesa Pond M5	NV10779	J-652
Mesa Pond M7	NV10780	J-652

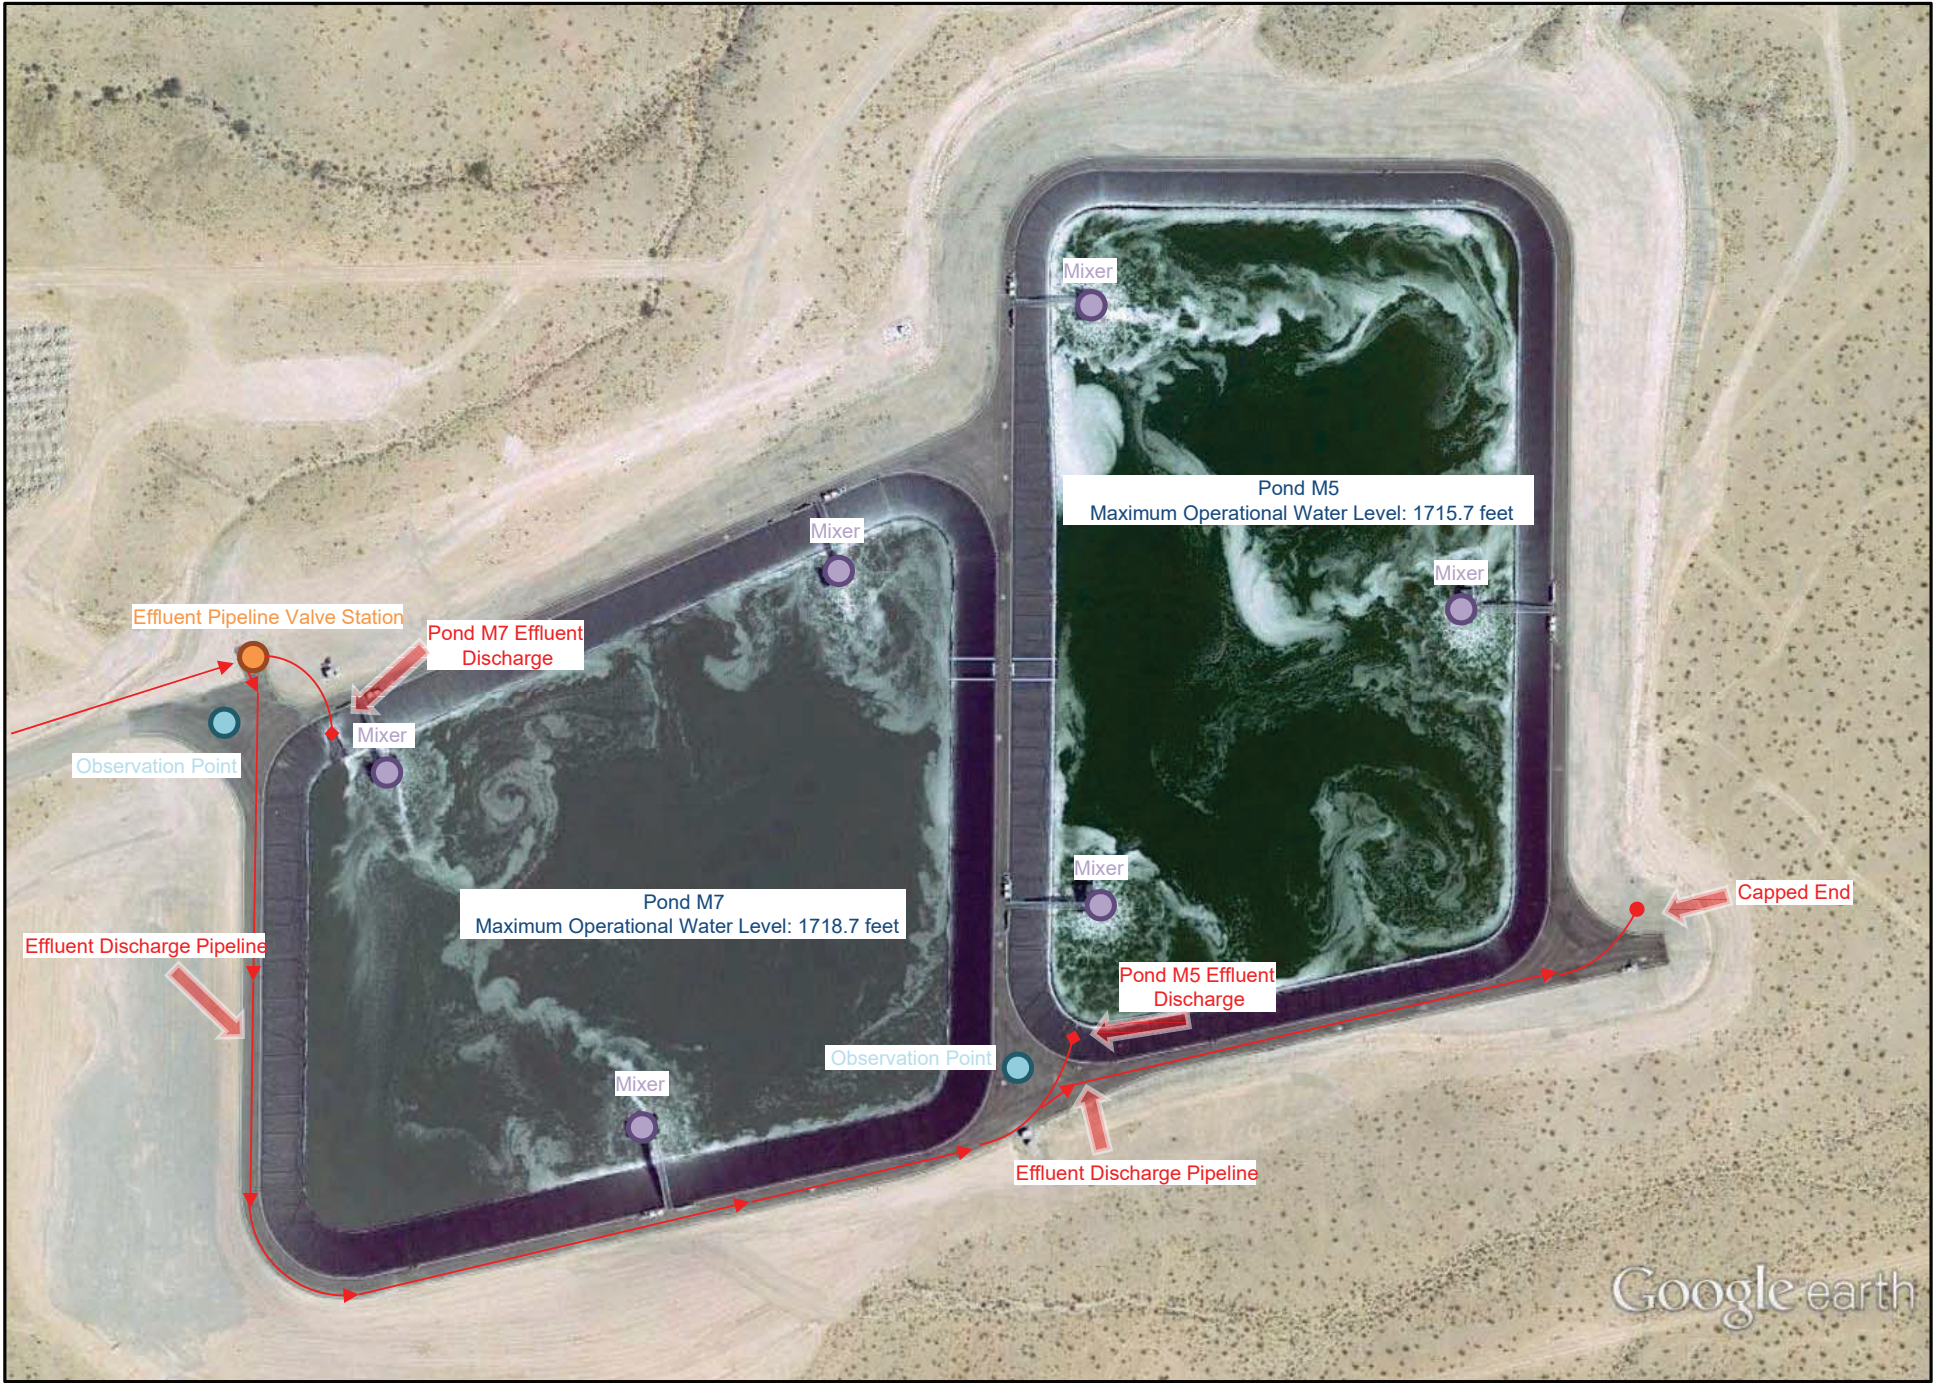
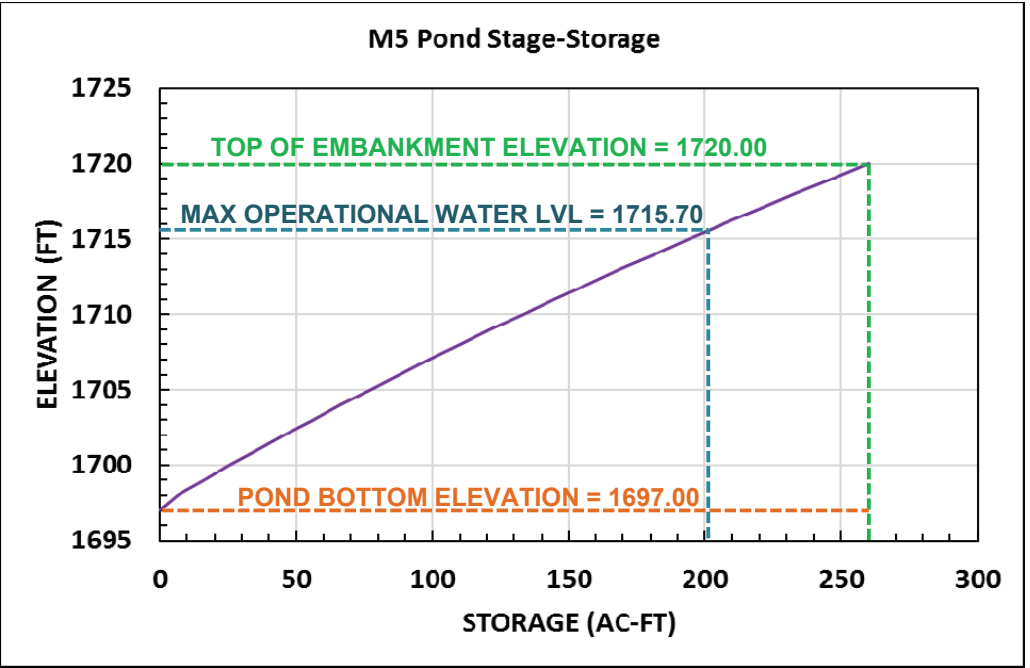
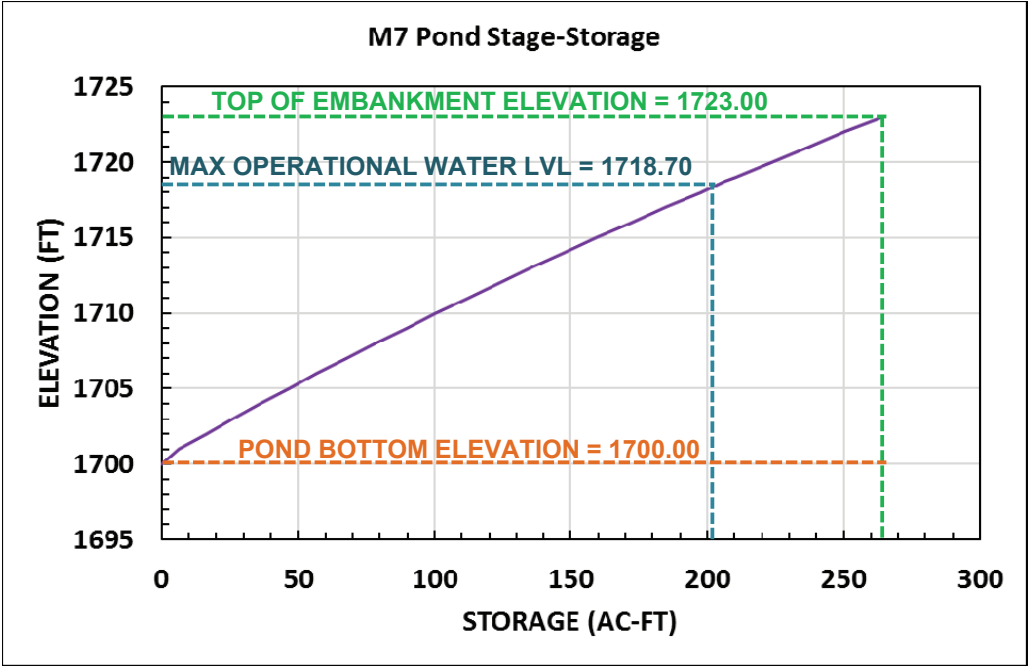
Figure 4-3. Dam Facilities Map  
Mesa Ponds M5 and M7  
Emergency Action Plan, Reid Gardner Station

- ← Effluent Discharge Pipeline
- Effluent Pipeline Valve Station
- Mixer
- Observation Point
- ◆ Pond Effluent Discharge Point

Table 4-1 presents the design information summary for the Mesa Ponds M5 and M7. The pond information was taken from the record drawings for the Mesa Evaporation Ponds (Appendix B). Figure 4-3 shows the facility features and storage curves of the Mesa Ponds. The ponds are lined with two layers of high-density polyethylene (HDPE) geomembrane with an interstitial leak detection and collection system.

Wastewater was fed to the M ponds from an 8-inch diameter HDPE pipeline running from the effluent forwarding pump station at the former generating station to a valve Station located at the northwest corner of Pond M7 (Figure 4-3). The valve Station routes flow into one of three HDPE underground pipes for discharge into the ponds. One pipe discharges into Pond M5, one into Pond M7, and the third is

Within the ponds, HDPE markers are welded to the HDPE geomembranes to mark the maximum operational water level, and staff gauges are installed on one bridge in each pond. These markers and gauges are visually inspected to assess water depth. The maximum operational water levels for Ponds M5 and M7 are 1,715.70 and 1,718.70 feet above mean sea level, respectively (Figure 4-3). Vertical datum is the North American Vertical Datum of 1988. As of January 2025, less than 4 feet of water and pond solids exists in each Pond. Removal of pond solids and the geomembrane liner system is scheduled to occur by the first quarter of 2026.

- Water surface elevation is above maximum operational level. The maximum operational water levels for Ponds M5 and M7 are 1,715.70 and 1,718.70 feet above mean sea level, respectively (Figure 4-3). Vertical datum is the North American Vertical Datum of 1988 (i.e., NAVD 88).
- New seepage or leakage through the dam requires increased monitoring and assessment.
- Unauthorized persons appear to be watching or surveilling the dam.
- Malfunction of water conveyance infrastructure.

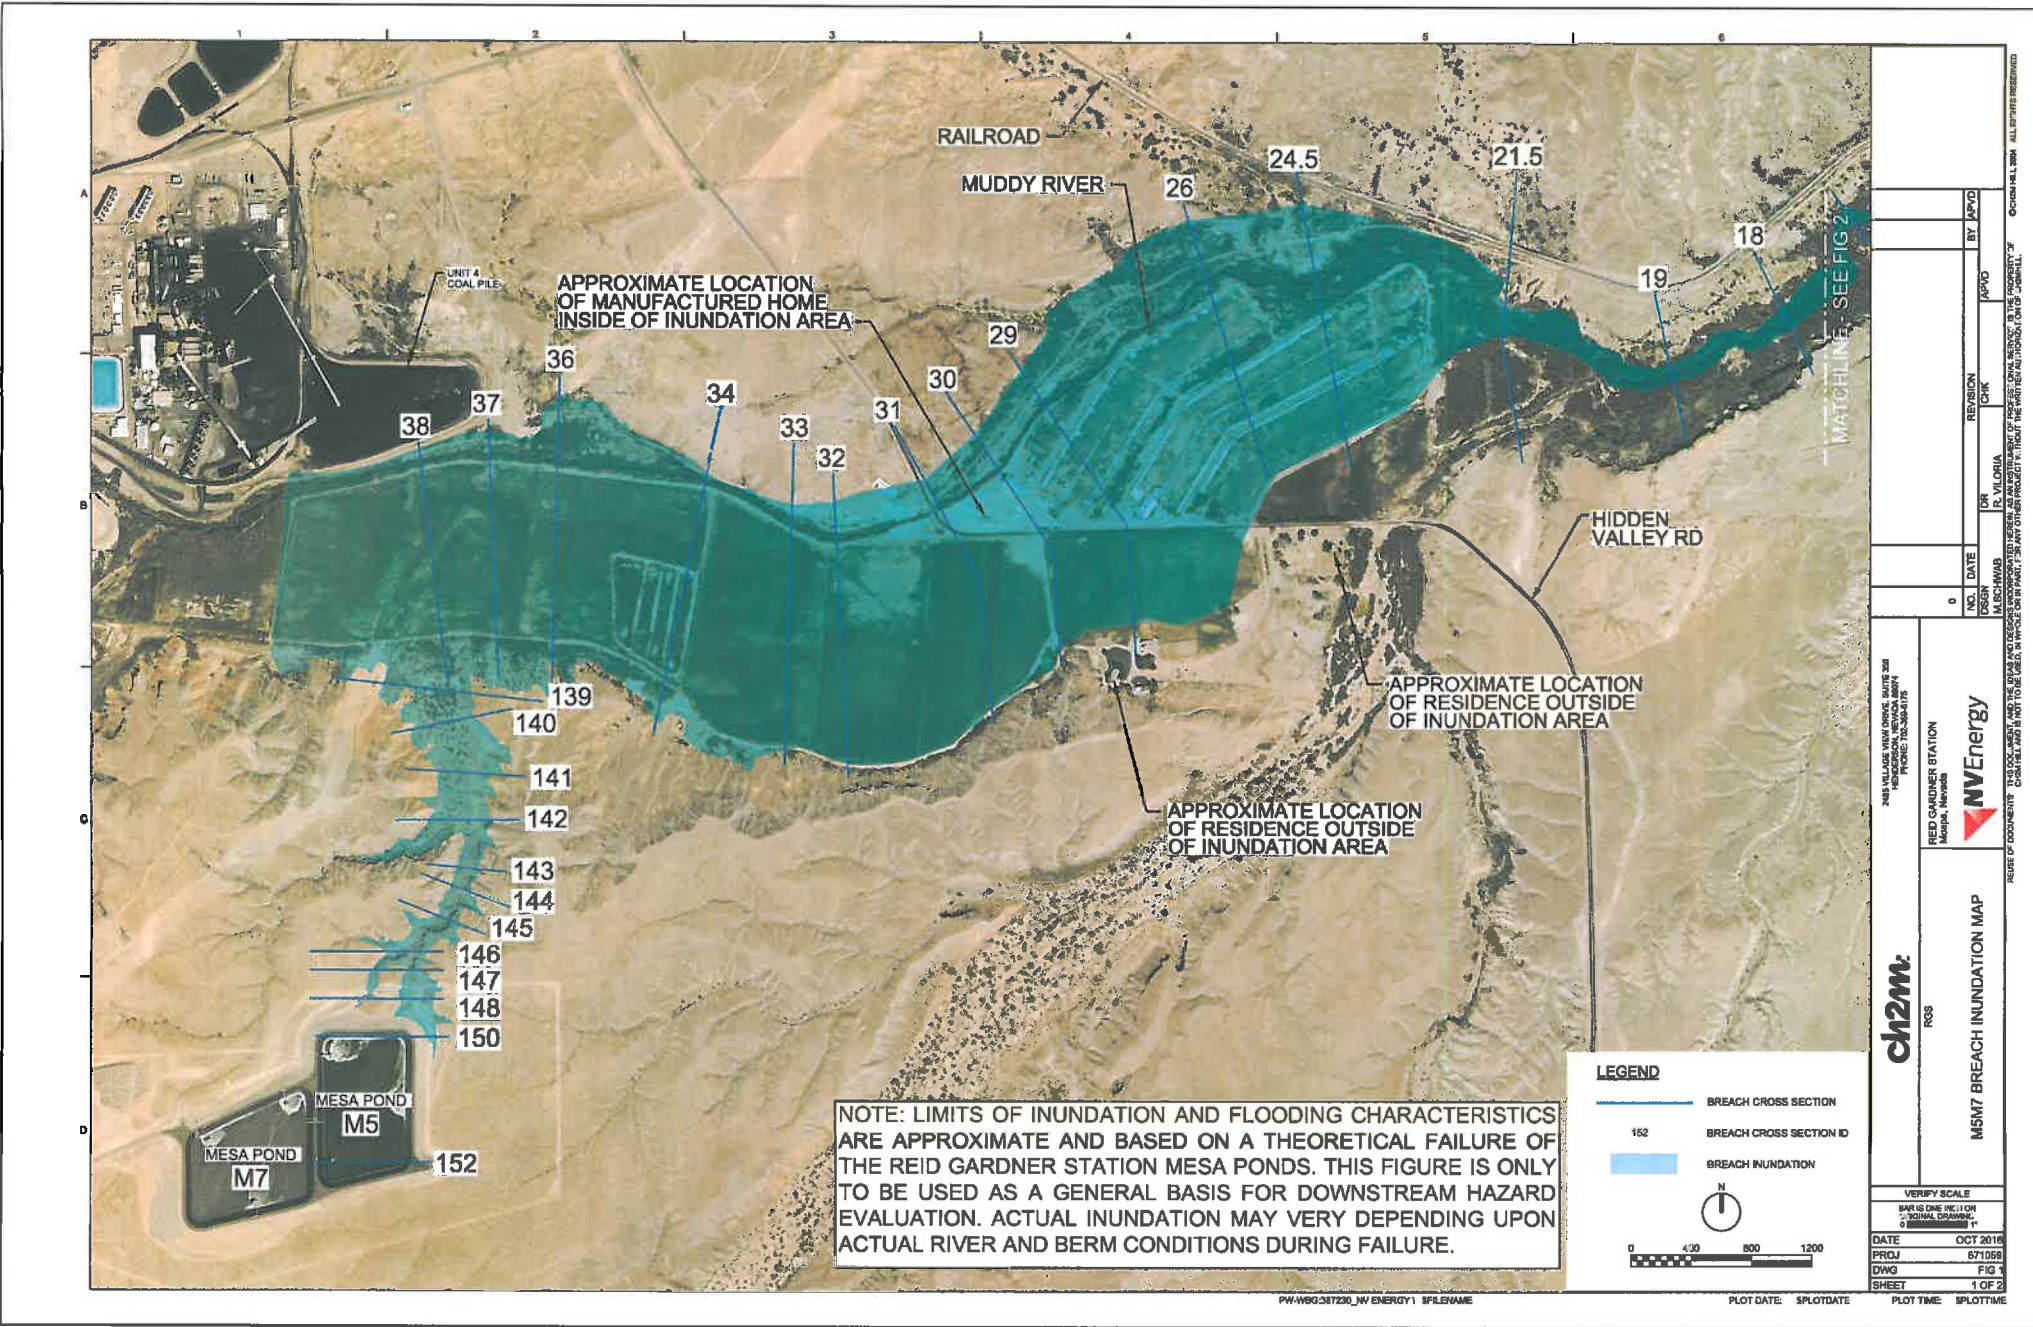
Figure 8-1, M5M7 Breach Inundation Map, 1of2, and Figure 8-2, M5M7 Breach Inundation Map, 2of2, on the following pages show the inundation limits due to the “sunny day” failure scenario analyzed for Pond M5. The breach inundation modeling files used to generate the inundation map is located in Appendix D.

Limits of inundation and flooding characteristics shown on the map are approximate and based on the theoretical failure of the Mesa Ponds described above. This map is only to be used as a general basis for downstream hazard evaluation. Actual inundation and flood wave characteristics may vary depending upon actual river and berm conditions during failure.

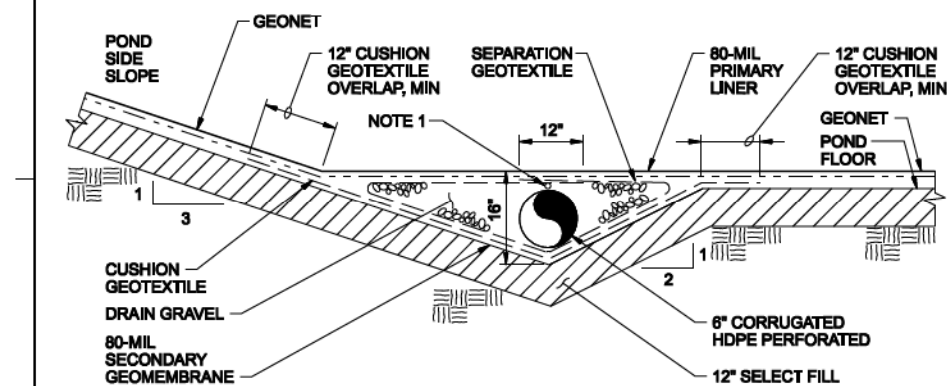
**2 LDRS COLLECTOR**  
NTS

NOTES:  
1. LDRS SURVEY WIRE: 8GA COPPER. TAPE TO TOP OF LDRS COLLECTOR PIPE @ 24" OC.

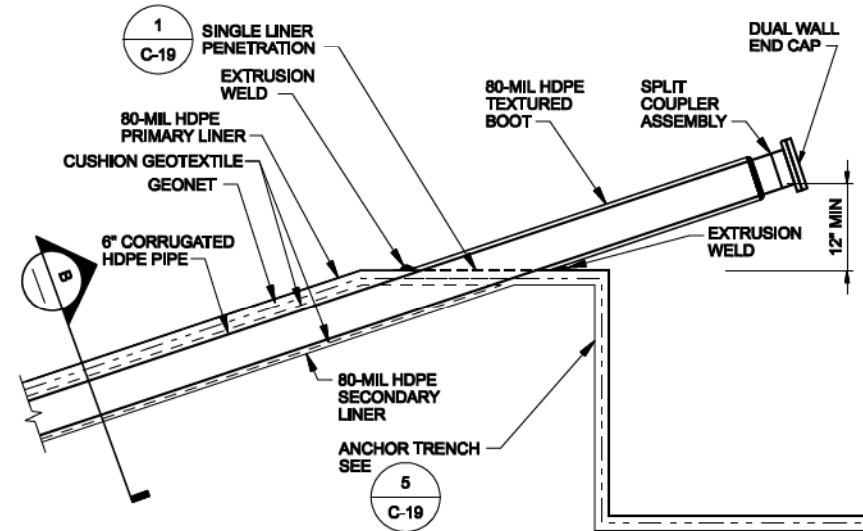
**3 BRIDGE PIER LINER PENETRATION MINIMUM REQUIREMENTS**  
NTS

- SOLID-WALL HDPE PIPE ENCLOSES THE CONCRETE COLUMNS FOR THE MIXER ACCESS WALKWAY PIER. SEE DRAWING S-2.
- THIS DETAIL REPRESENTS THE MINIMUM DESIGN REQUIREMENTS FOR THIS PENETRATION. CONTRACTOR CAN ALTER OR ADJUST AS NEEDED TO MATCH BRIDGE PIER DESIGN, AND TO MEET PERFORMANCE REQUIREMENTS FOR PROJECT.
- LINER FOR PROTECTION OF MAT FOOTING IS NOT SHOWN ON THIS DETAIL, SEE DWG S-11B. REINFORCED LINER LAYER (NOT SHOWN) INSTALLED OVER PENETRATION AND SKIRT, SEE DWG C-19.

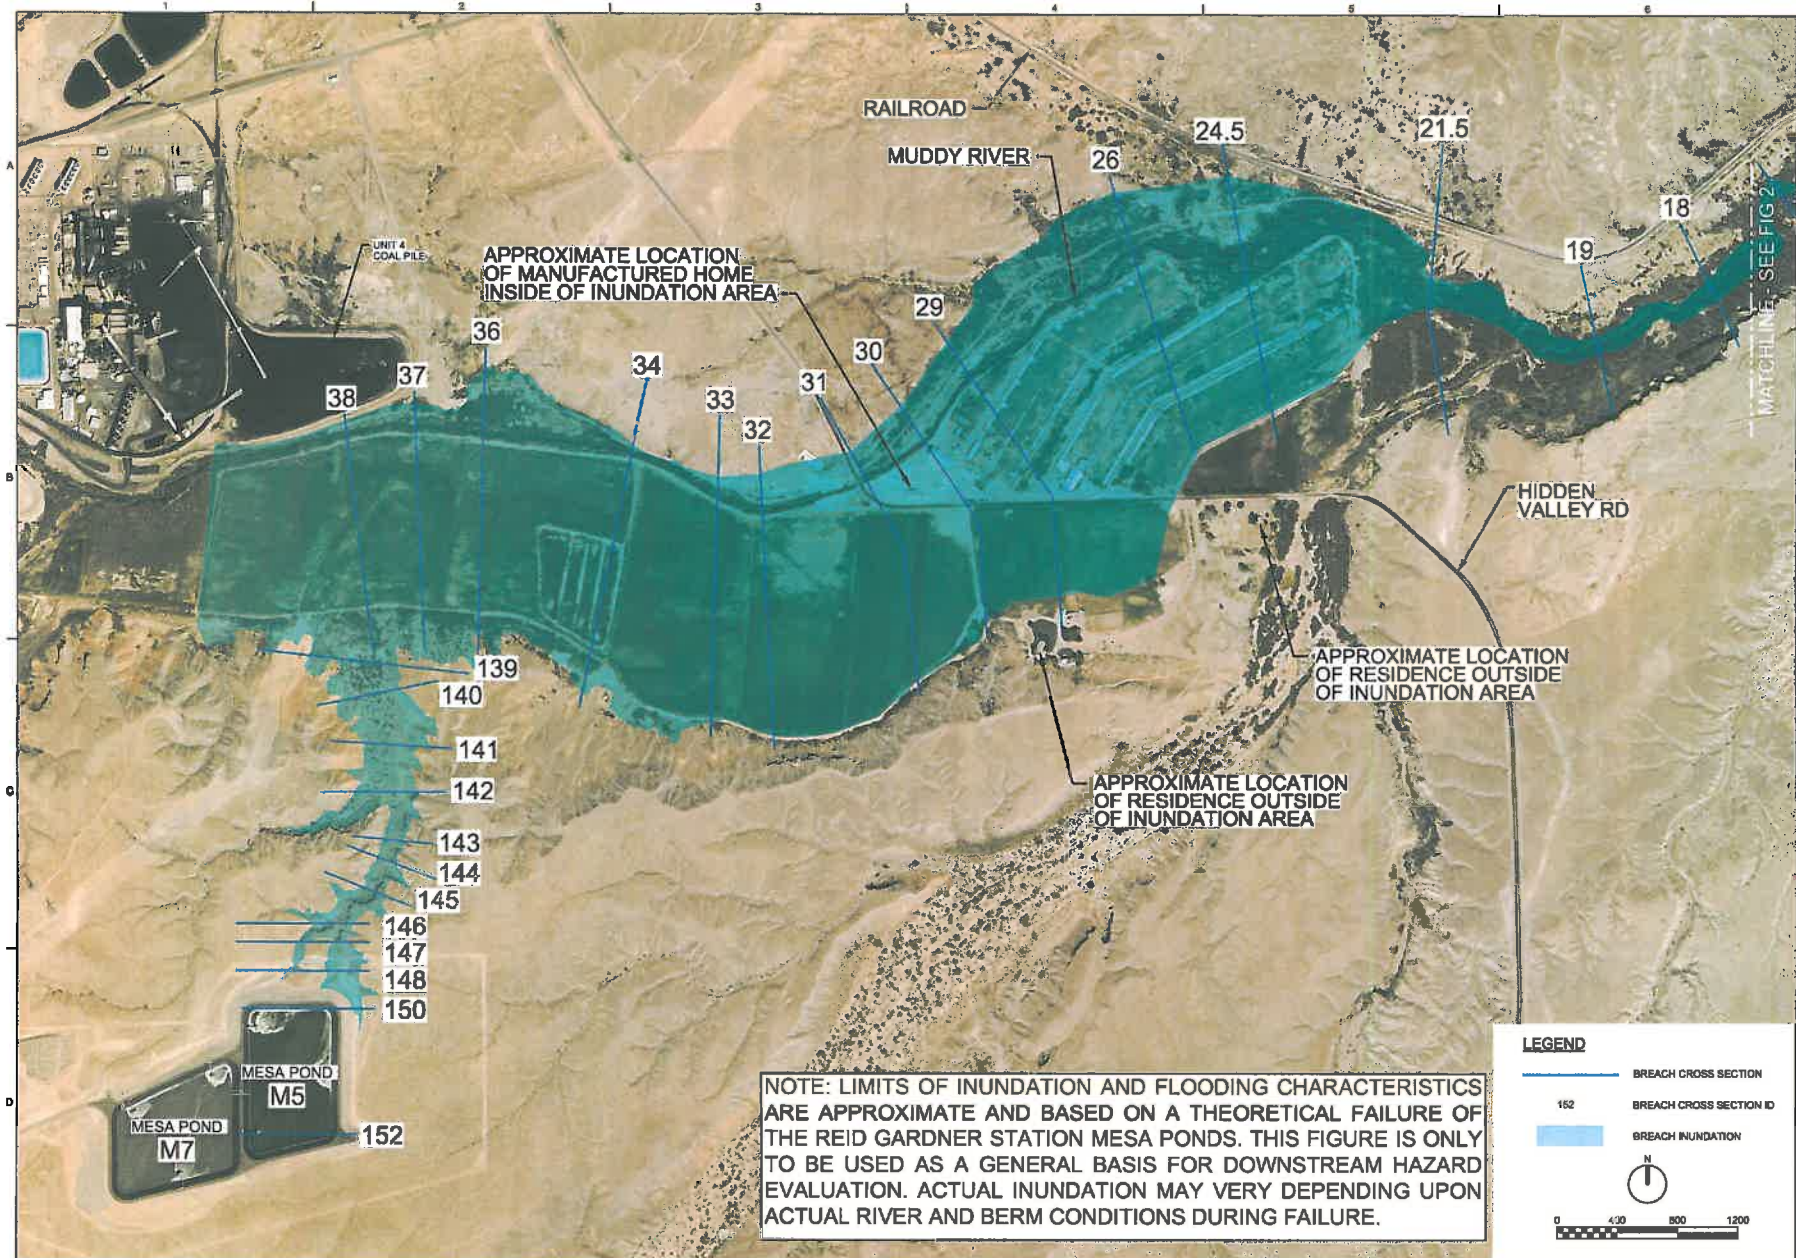
## **Inundation Map – 2016**

NOTE: LIMITS OF INUNDATION AND FLOODING CHARACTERISTICS ARE APPROXIMATE AND BASED ON A THEORETICAL FAILURE OF THE REID GARDNER STATION MESA PONDS. THIS FIGURE IS ONLY TO BE USED AS A GENERAL BASIS FOR DOWNSTREAM HAZARD EVALUATION. ACTUAL INUNDATION MAY VARY DEPENDING UPON ACTUAL RIVER AND BERM CONDITIONS DURING FAILURE.

Ponds M5 and M7 are located on top of a plateau, approximately 150 vertical feet above the Muddy River floodplain. The downstream inundation resulting from a breach of the embankment or overtopping of the embankment of Ponds M5 and M7 migrates through well incised cavernous washes in a northerly direction and then turns east into a Zone 'AE' with Floodway SFHA that encumbers the Muddy River floodplain, per Flood Insurance Rate Map (FIRM) Panels 32003C0670E and 32003C0690E dated September 27, 2002. Figure 1 included in Attachment 4 displays the SFHA from the FEMA FIRM panels along with the breach inundation boundary that extends from the Ponds to the Muddy River floodplain. The inundation boundary is shown by extent of the flood water surface elevation lines

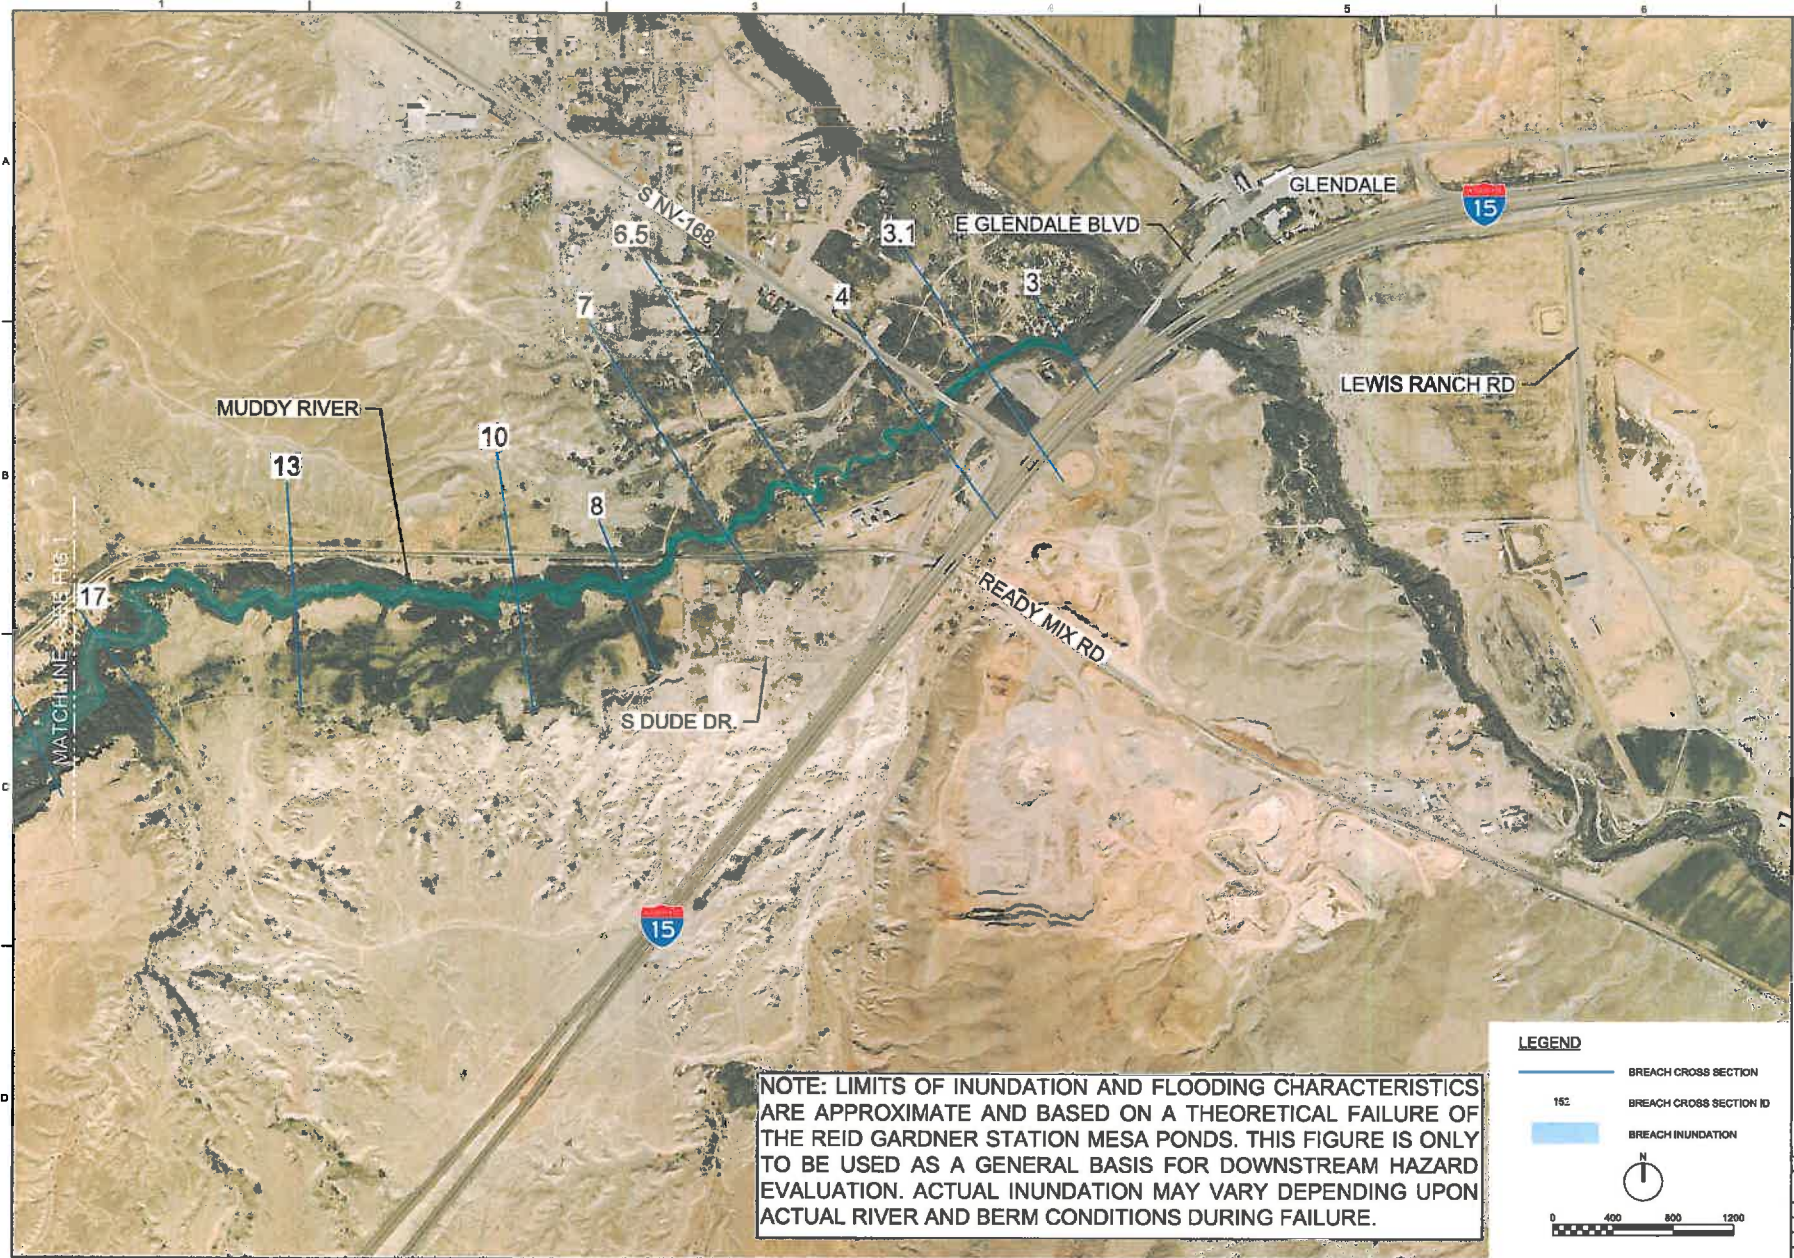
NOTE: LIMITS OF INUNDATION AND FLOODING CHARACTERISTICS ARE APPROXIMATE AND BASED ON A THEORETICAL FAILURE OF THE REID GARDNER STATION MESA PONDS. THIS FIGURE IS ONLY TO BE USED AS A GENERAL BASIS FOR DOWNSTREAM HAZARD EVALUATION. ACTUAL INUNDATION MAY VARY DEPENDING UPON ACTUAL RIVER AND BERM CONDITIONS DURING FAILURE.

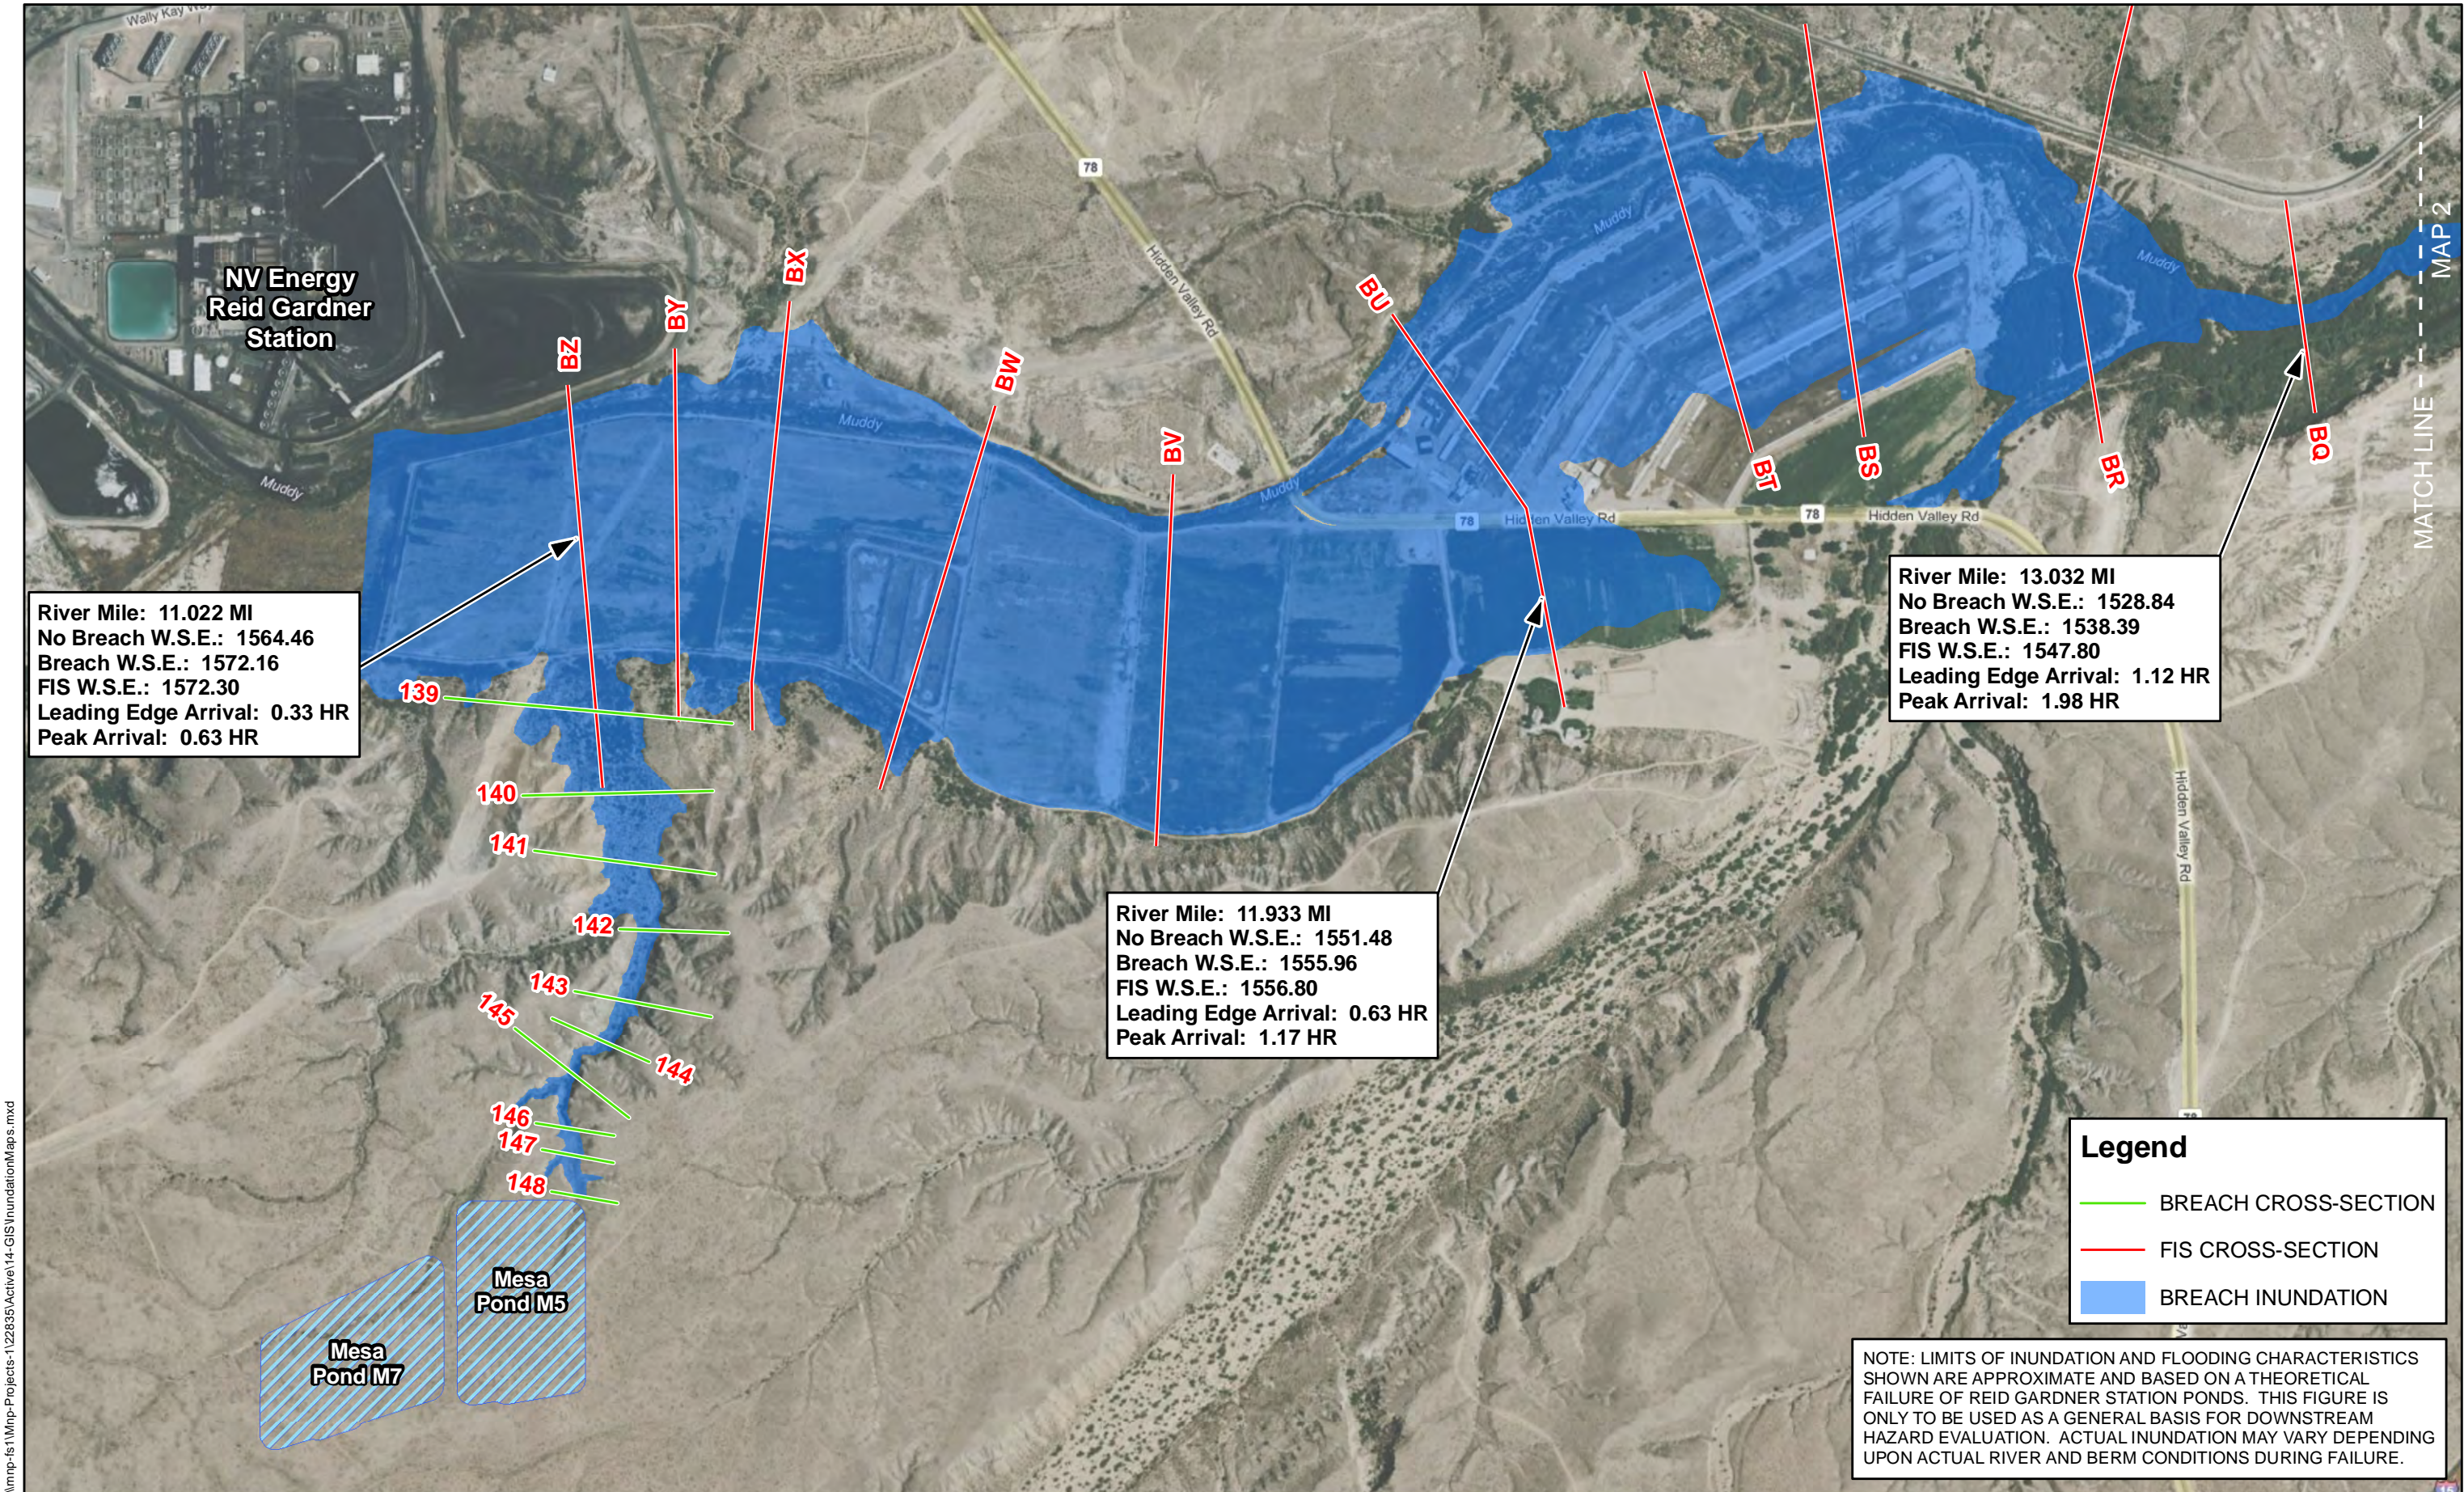
**Attachment 2**  
**Dam Breach Inundation Results – 2010 Analysis**

NOTE: LIMITS OF INUNDATION AND FLOODING CHARACTERISTICS SHOWN ARE APPROXIMATE AND BASED ON A THEORETICAL FAILURE OF REID GARDNER STATION PONDS. THIS FIGURE IS ONLY TO BE USED AS A GENERAL BASIS FOR DOWNSTREAM HAZARD EVALUATION. ACTUAL INUNDATION MAY VARY DEPENDING UPON ACTUAL RIVER AND BERM CONDITIONS DURING FAILURE.

- BREACH CROSS-SECTION
- FIS CROSS-SECTION
- BREACH INUNDATION

- The Dam Breach Model results are compared in Table 1 to the FIS water surface elevations which are representative of the 100-year flood.
- Table 2 compares the Dam Breach Model sunny day failure peak elevations with the Dam Breach Model no failure elevations.
- Maps 1 and 2 display the analysis cross-sections, inundation and floodplain extents, and aerial imagery.
- The flows for the 10 and 50 year events were not available for the upper reach of Muddy River and floodplain extents were not available for the full reach of Muddy River.

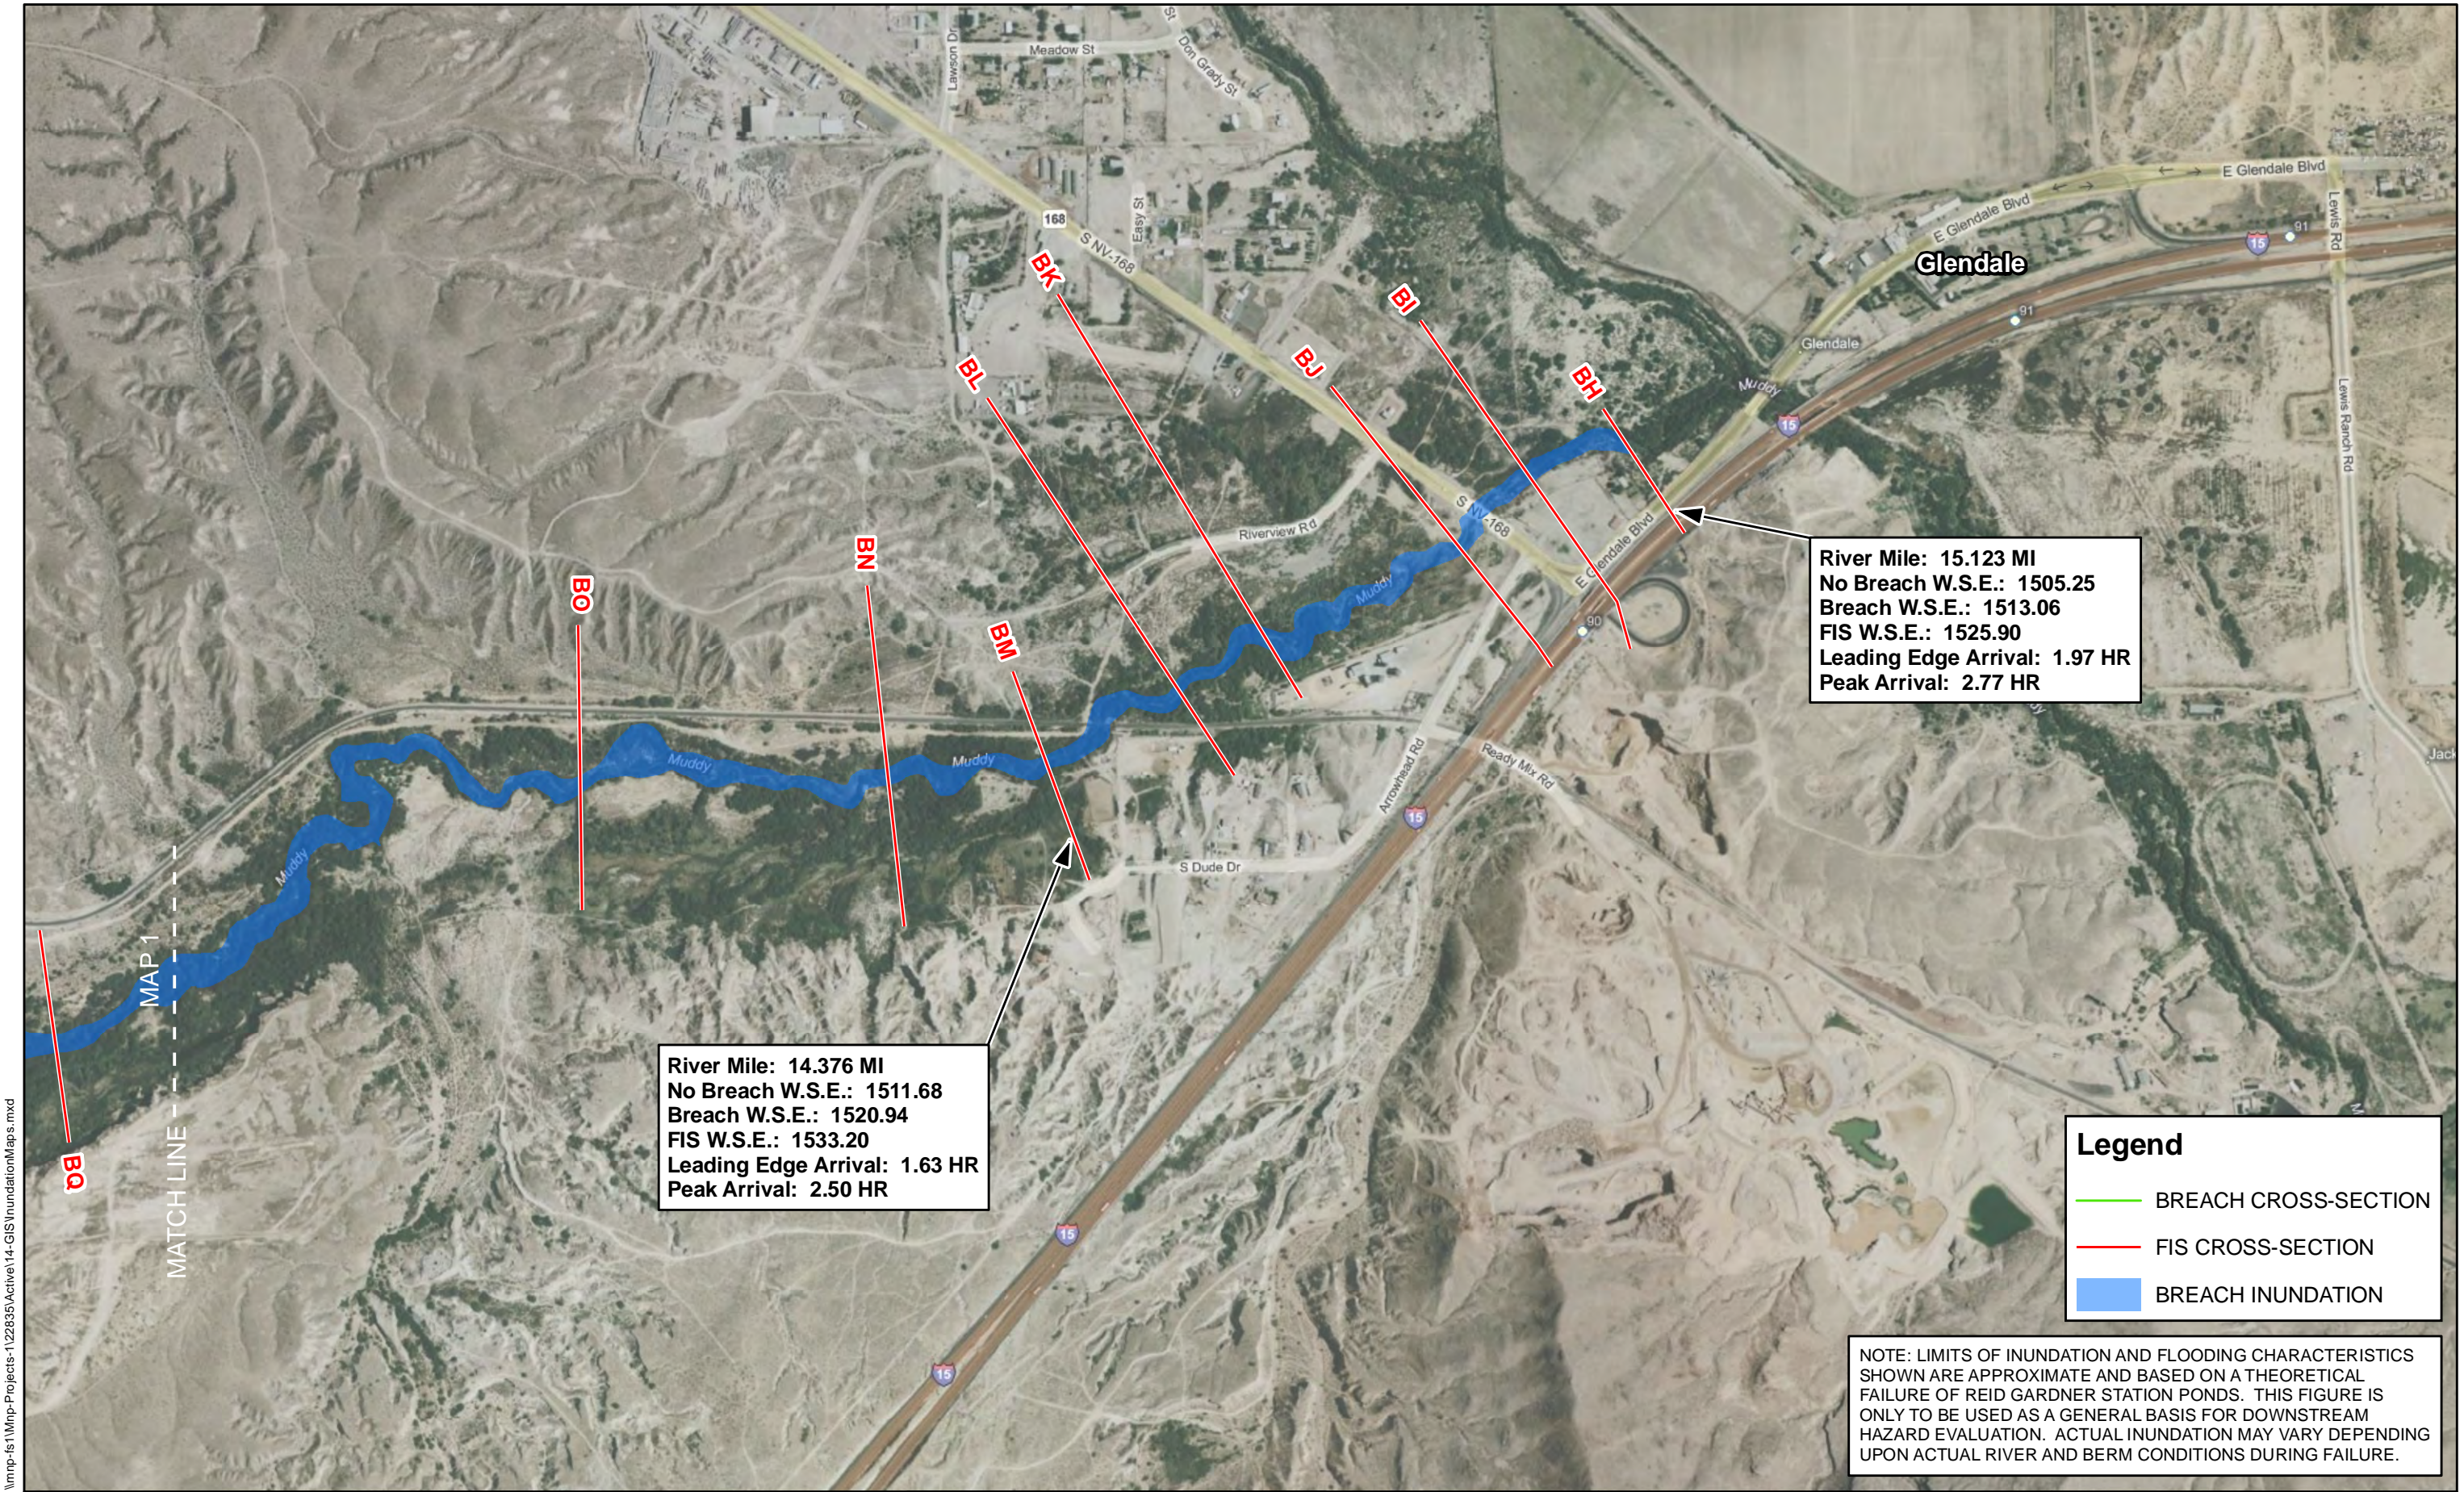
River Mile: 15.123 MI  
No Breach W.S.E.: 1505.25  
Breach W.S.E.: 1513.06  
FIS W.S.E.: 1525.90  
Leading Edge Arrival: 1.97 HR  
Peak Arrival: 2.77 HR

River Mile: 14.376 MI  
No Breach W.S.E.: 1511.68  
Breach W.S.E.: 1520.94  
FIS W.S.E.: 1533.20  
Leading Edge Arrival: 1.63 HR  
Peak Arrival: 2.50 HR

NOTE: LIMITS OF INUNDATION AND FLOODING CHARACTERISTICS SHOWN ARE APPROXIMATE AND BASED ON A THEORETICAL FAILURE OF REID GARDNER STATION PONDS. THIS FIGURE IS ONLY TO BE USED AS A GENERAL BASIS FOR DOWNSTREAM HAZARD EVALUATION. ACTUAL INUNDATION MAY VARY DEPENDING UPON ACTUAL RIVER AND BERM CONDITIONS DURING FAILURE.

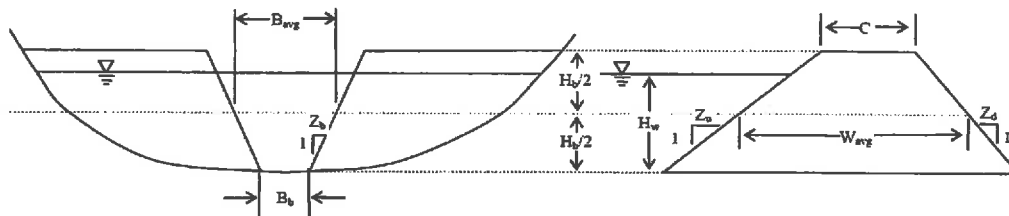
**Figure 1- Breach Variable Definition Sketch**

Select Failure Mode From Drop-Down Menu: **OVERTOPPING**

Height of water over base elevation of breach ( $H_w$ ) =	23.0	Feet
Volume of water in the reservoir at the time of failure ( $V_w$ ) =	260.0	Acre-Feet
Reservoir Surface Area at $H_w$ ( $A_s$ ) =	13.8	Acres
Height of breach ( $H_b$ ) =	23.0	Feet
Failure Mode Factor ( $K_c$ ) =	1.3	
Breach Side-Slope Ratio ( $Z_b$ ) =	1	$Z(H):1(V)$
Dam Size Class:	Small	Assumes Full Reservoir At Time of Breach.

Average Breach Width Divided by Height of Breach ( $B_{avg}/H_b$ ) =	3.13	If $(B_{avg}/H_b) > 0.6$ , Full Breach Development is Anticipated
Erosion Rate (ER), Calculated as ( $B_{avg}/T_f$ ) =	159.0	
Erosion Rate Divided by Height of Water Over Base of Breach ( $ER/H_w$ ) =	6.9	If $1.6 < (ER/H_w) < 21$ , Erosion Rate is Assumed Reasonable
