# Emergency Action Plan: Reid Gardner Station, Mesa Ponds M5 and M7

Revision 04

February 2025

Pond Name	National Inventory of Dam Number	Nevada State Identification Number
Mesa Pond M5	NV10779	J-652
Mesa Pond M7	NV10780	J-652

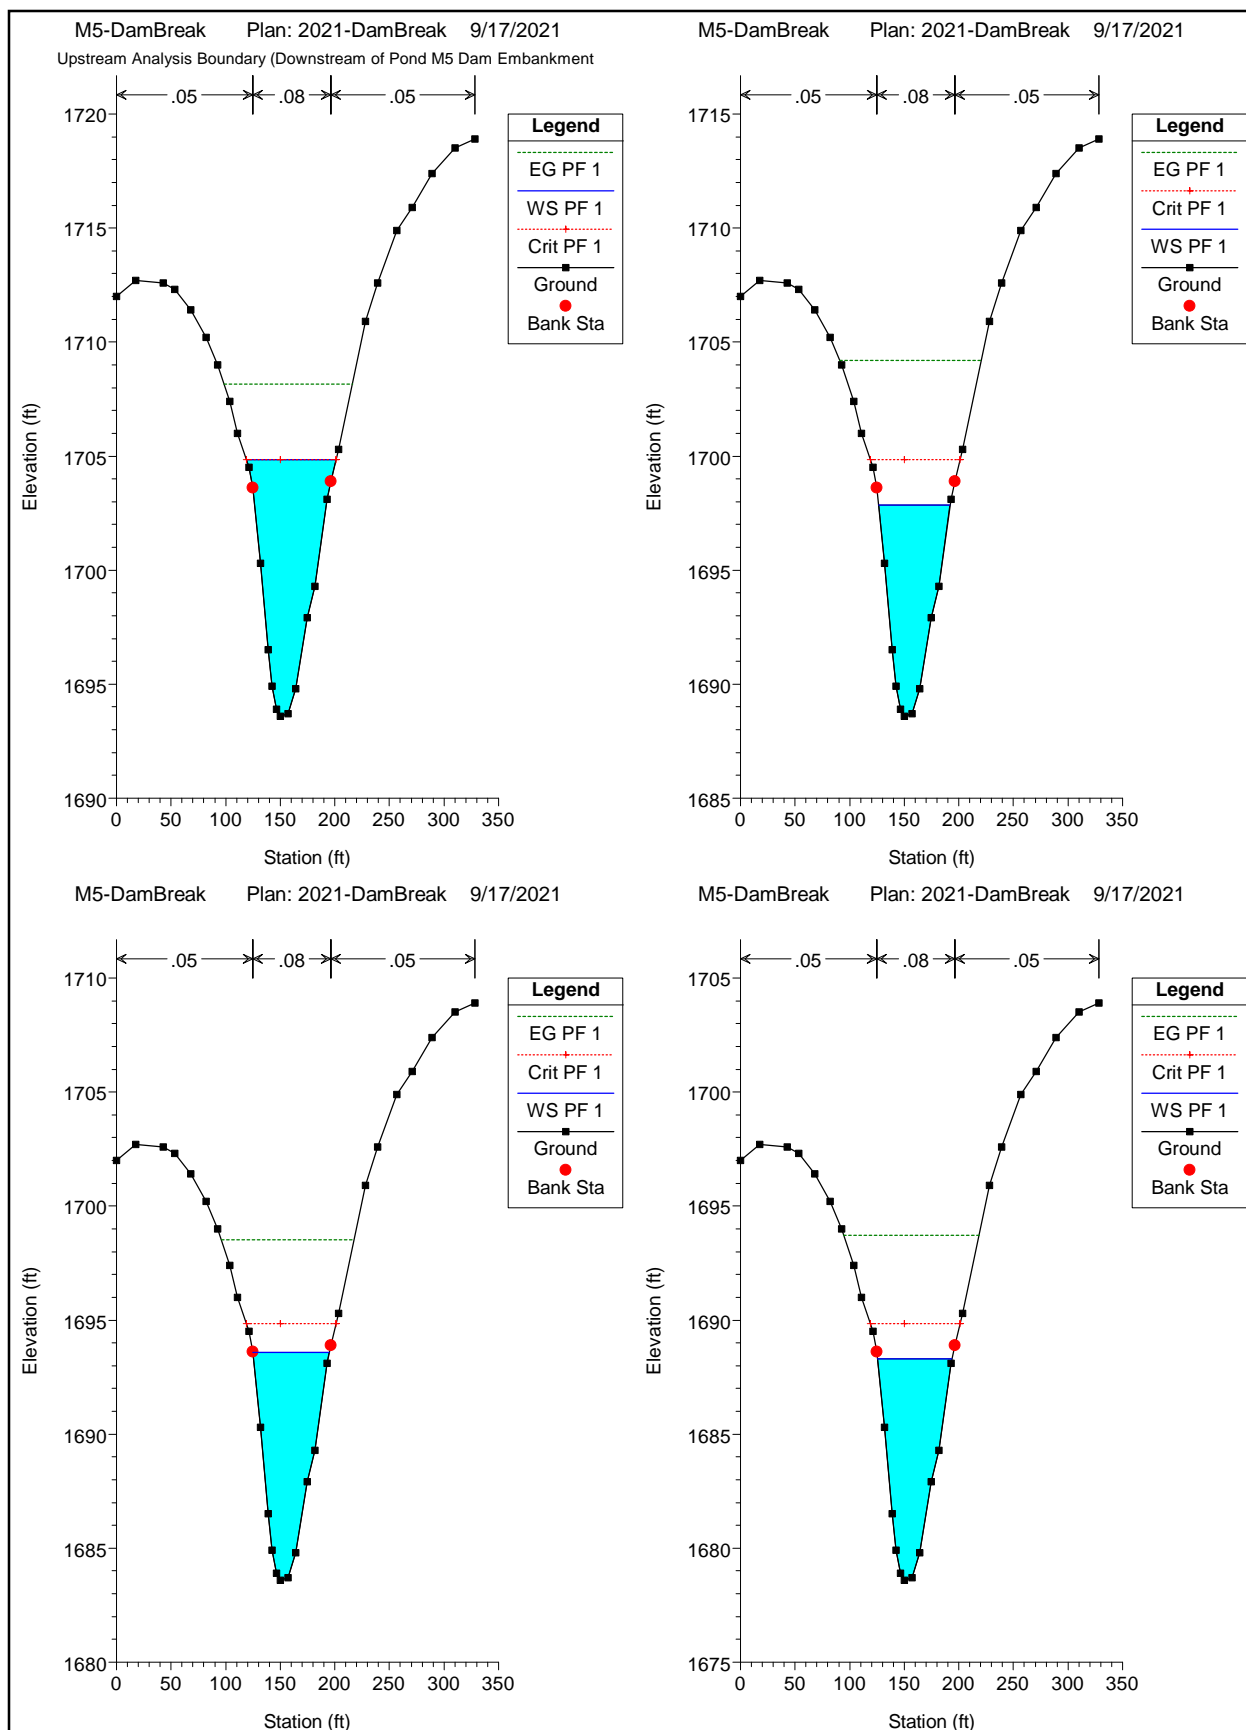
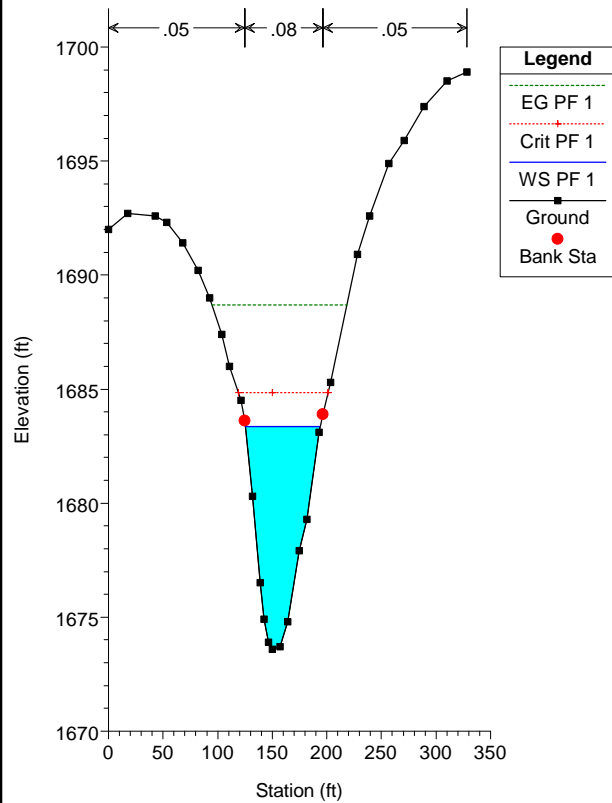
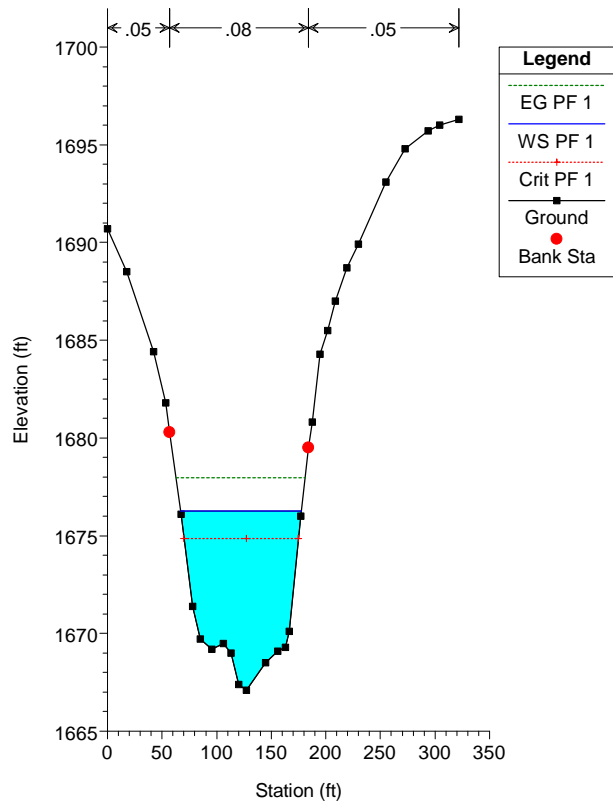
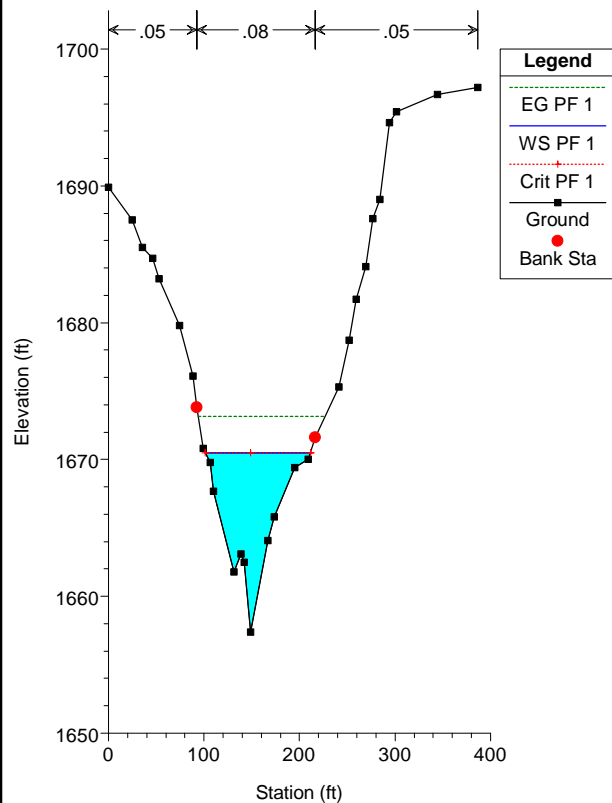
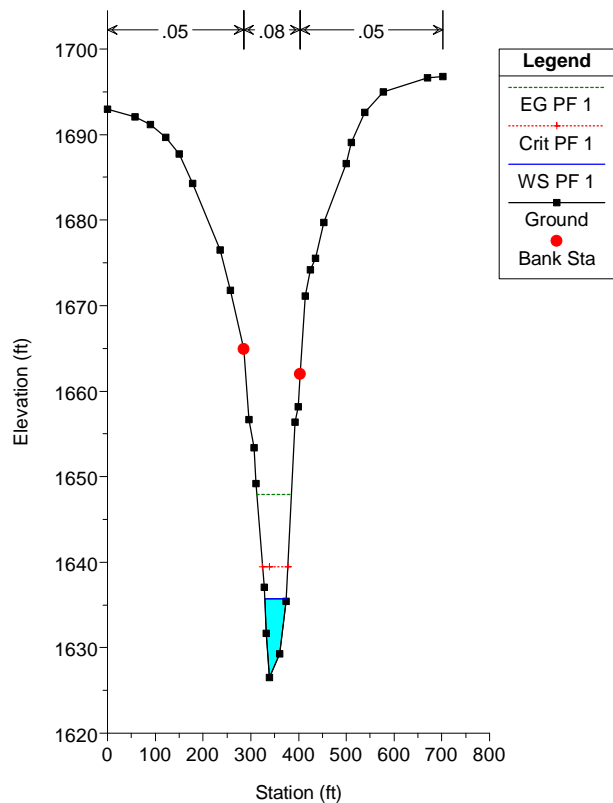
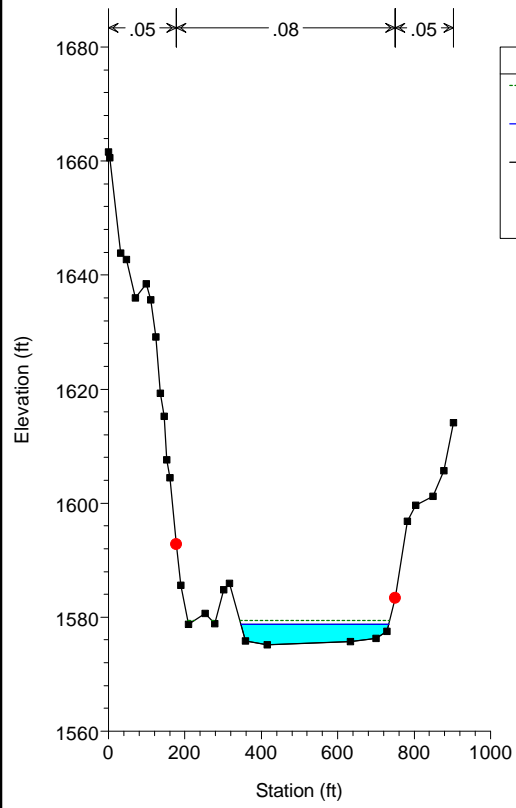
## **RAS Sections – 2021**

M5-DamBreak Plan: 2021-DamBreak 9/17/2021

M5-DamBreak Plan: 2021-DamBreak 9/17/2021  
Downstream Analysis Boundary (SFHA Boundary Muddy River)
