NV Energy Reid Gardner Station Mesa Ponds M5 and M7 and Raw Water Ponds Emergency Action Plans

Reid Gardner Dam Safety Emergency Action Plan (EAP) Annual Meeting – March 25, 2021

Emergency Action Plan – M5, M7 & Raw Water Ponds

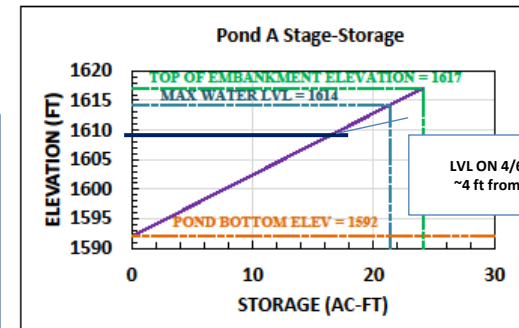
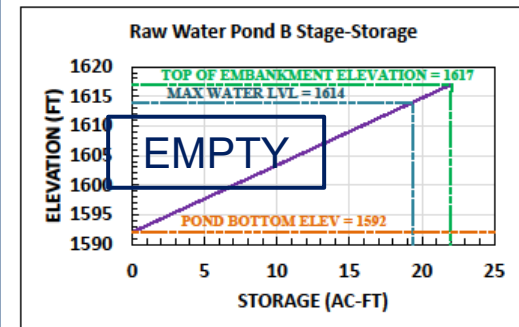
Figure 4-2
Dam Facilities Map
Raw Water Ponds
Dam Facilities and Hydraulic Information
Emergency Action Plan
Reid Gardner Station
Moapa, Nevada

Note: All elevations reference NAVD 1988 vertical datum

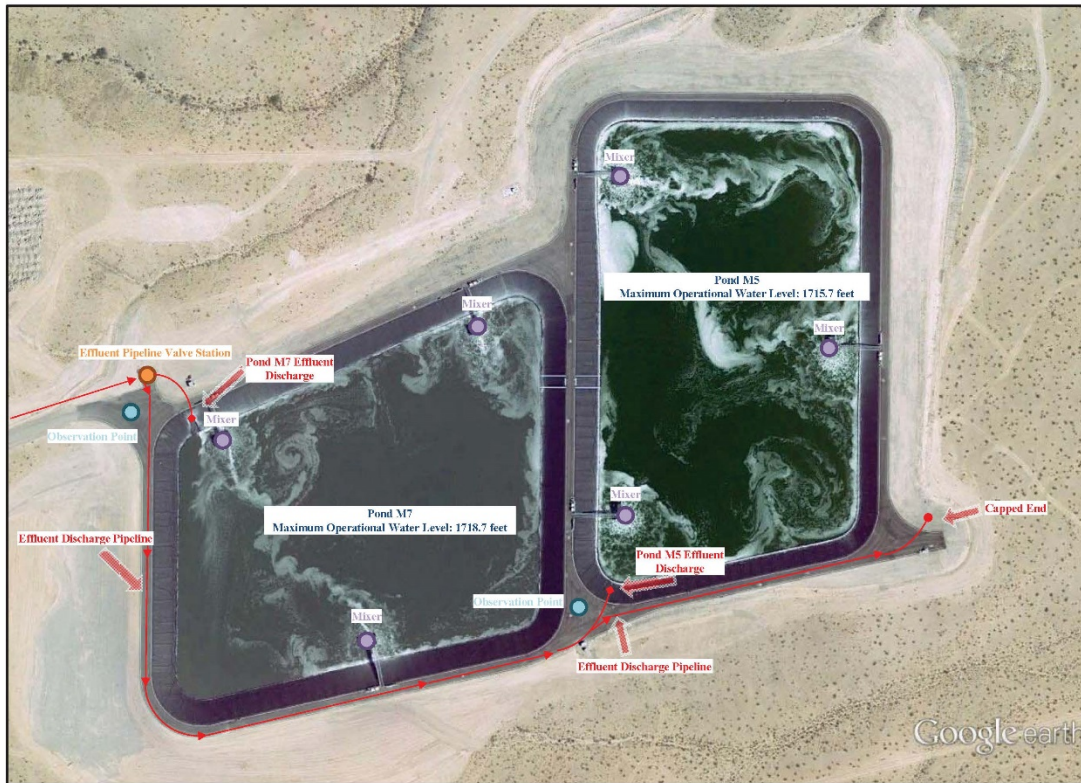
Figure 4-2
 Dam Facilities Map
 Mesa Ponds M5 and M7
 Dam Facilities and Hydraulic Information
 Emergency Action Plan
 Reid Gardner Station
 Moapa, Nevada

Note: all elevations reference NAVD 1988 vertical datum
